KLAMATH RIVER RENEWAL PROJECT:

Planning & Implementation for Complex Dam Removal

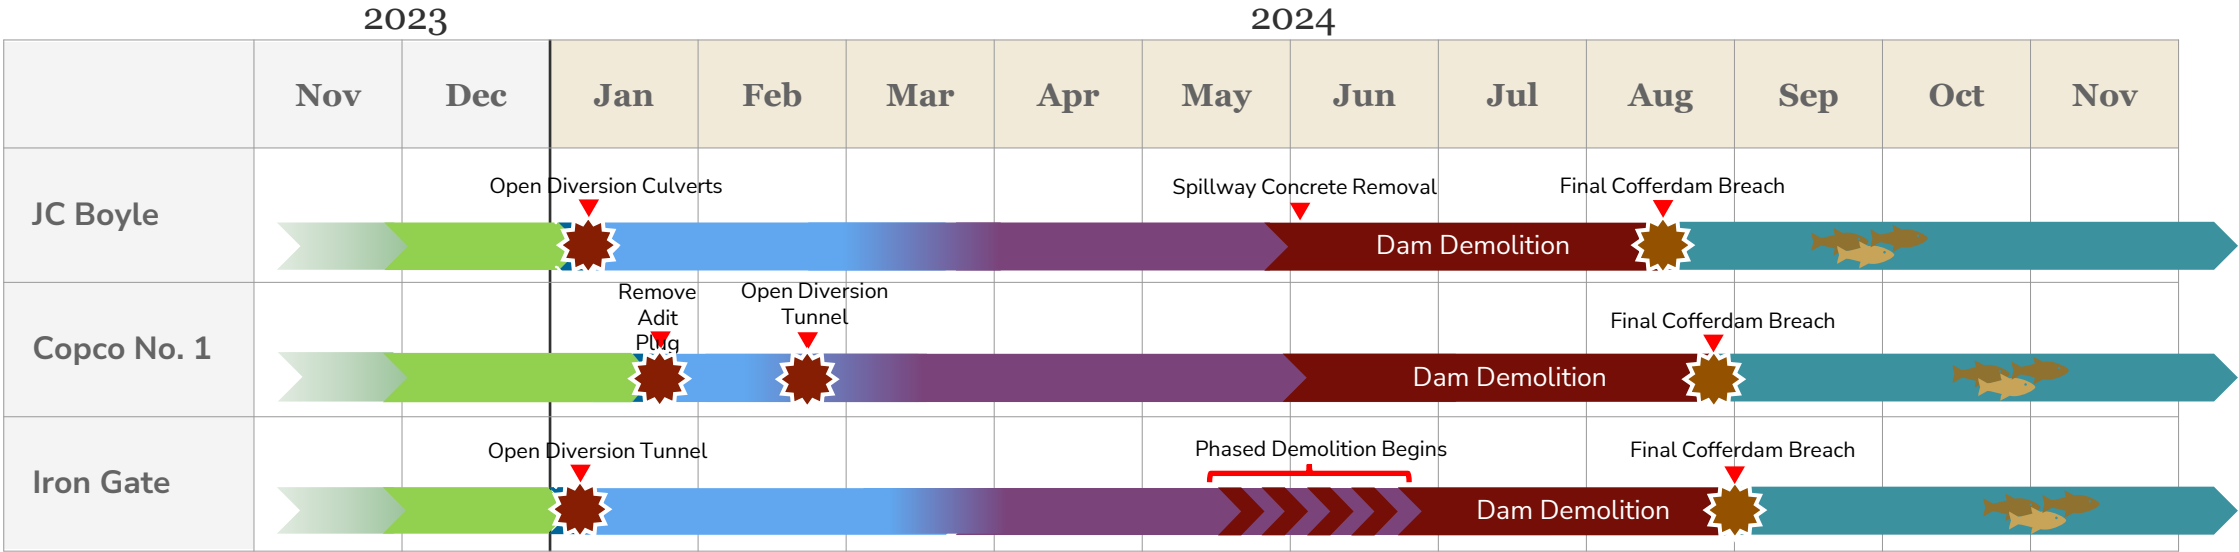
Stages of Reservoir Drawdown

1. Operational Drawdown:
Lowering reservoir to its minimum operating level

2. Initial Drawdown:
Reservoir water evacuation below the Operational Drawdown limits

3. Reservoir Refilling and Releasing Period:
Inflows exceed outflow capacity periodically, causing reservoir levels to rise and fall

4. Dam Demolition:
Reservoir water elevation remains at the top of the historic cofferdam while dam concrete and embankments are removed

5. Klamath River Reconnection:
Breaching of the historic cofferdam, allowing the river to permanently flow in a riverine condition

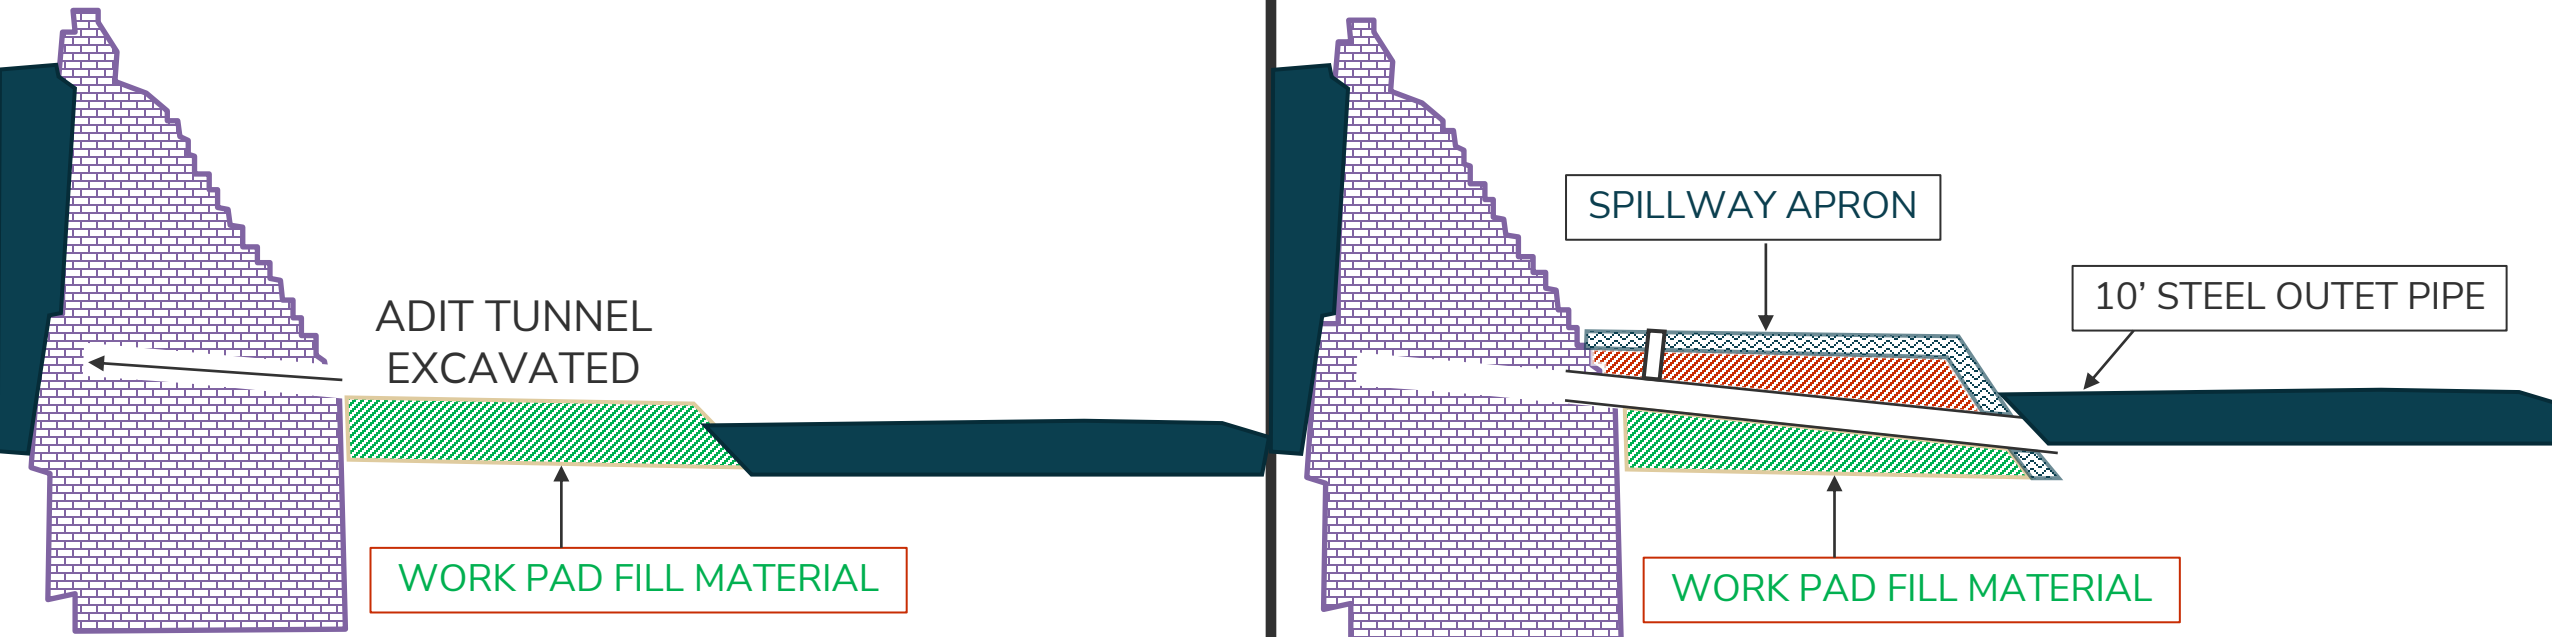
2023 Pre-Drawdown: Copco No. 1 Dam Adit Tunnel

- 1) Green work pad constructed on downstream side at base of dam.
- 2) 10' diameter adit tunnel excavated through base of dam. Plug left in place at upstream end.

- 3) 10' diameter extension pipe installed downstream of tunnel.
- 4) Extension pipe covered with spillway apron earthen material and grouted in place.

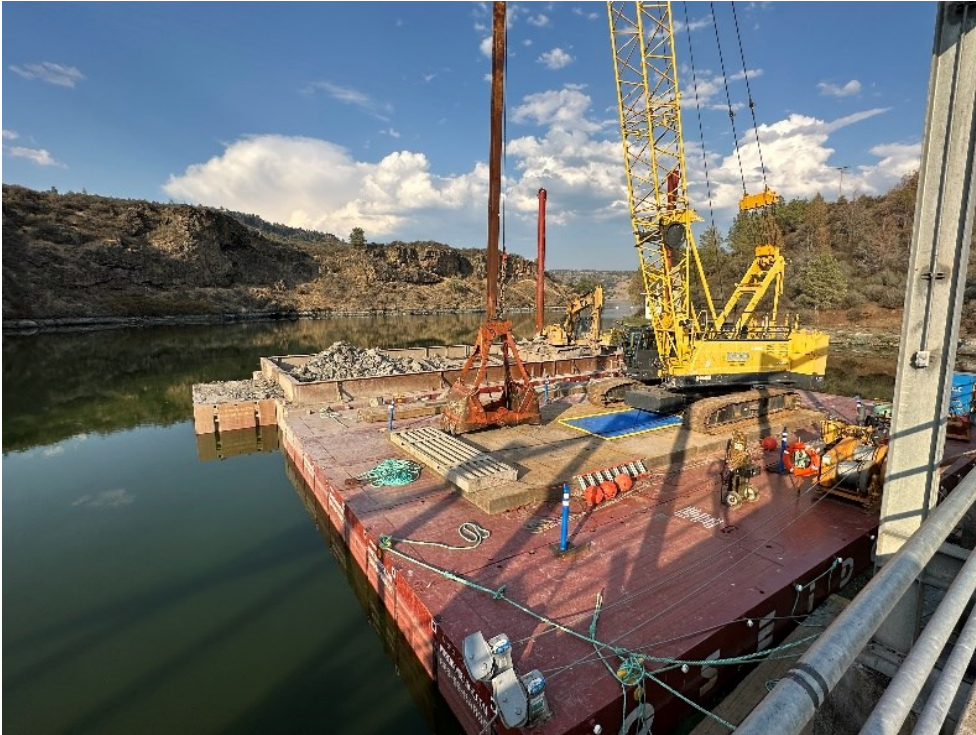
Dredging and debris barges moored at Copco 1 Dam while dredging in front of the new low-level adit. Debris, including rock and timbers, can be seen in the debris barge.

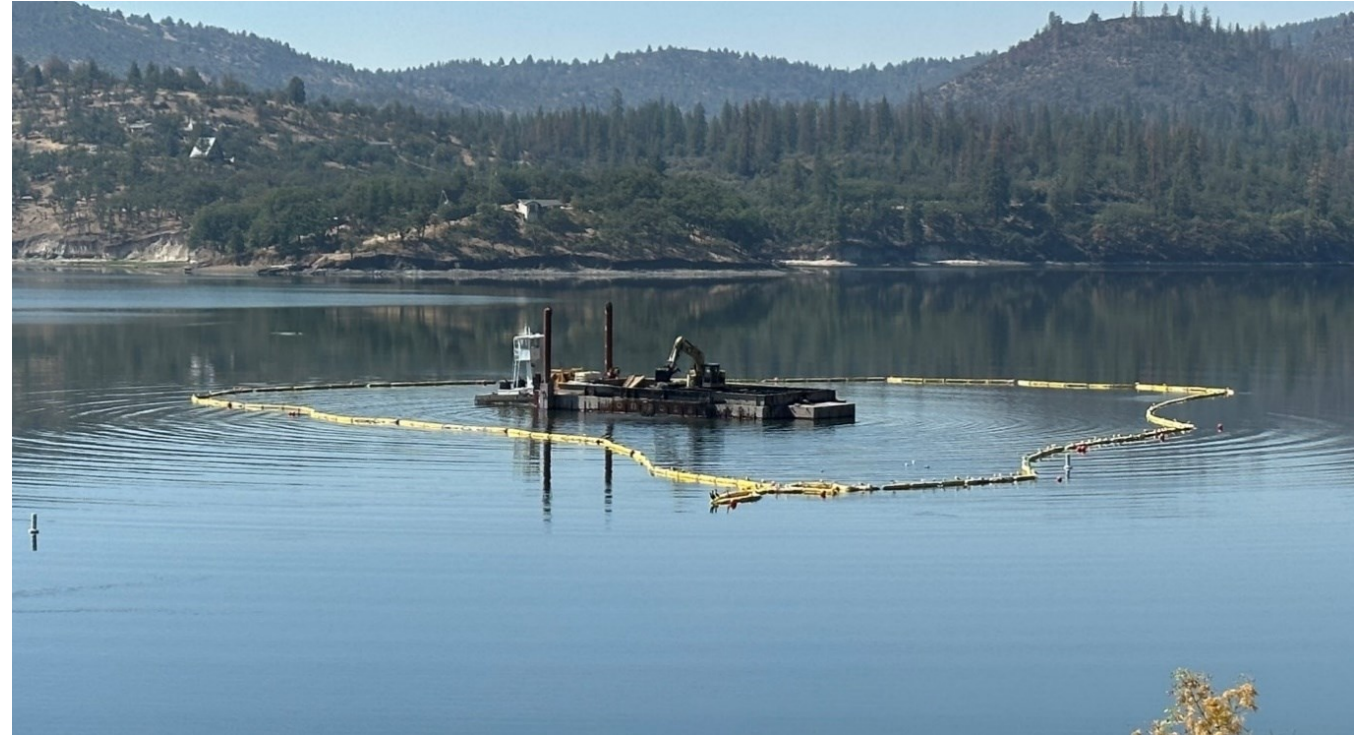
Offloading debris barge in dredging disposal area.

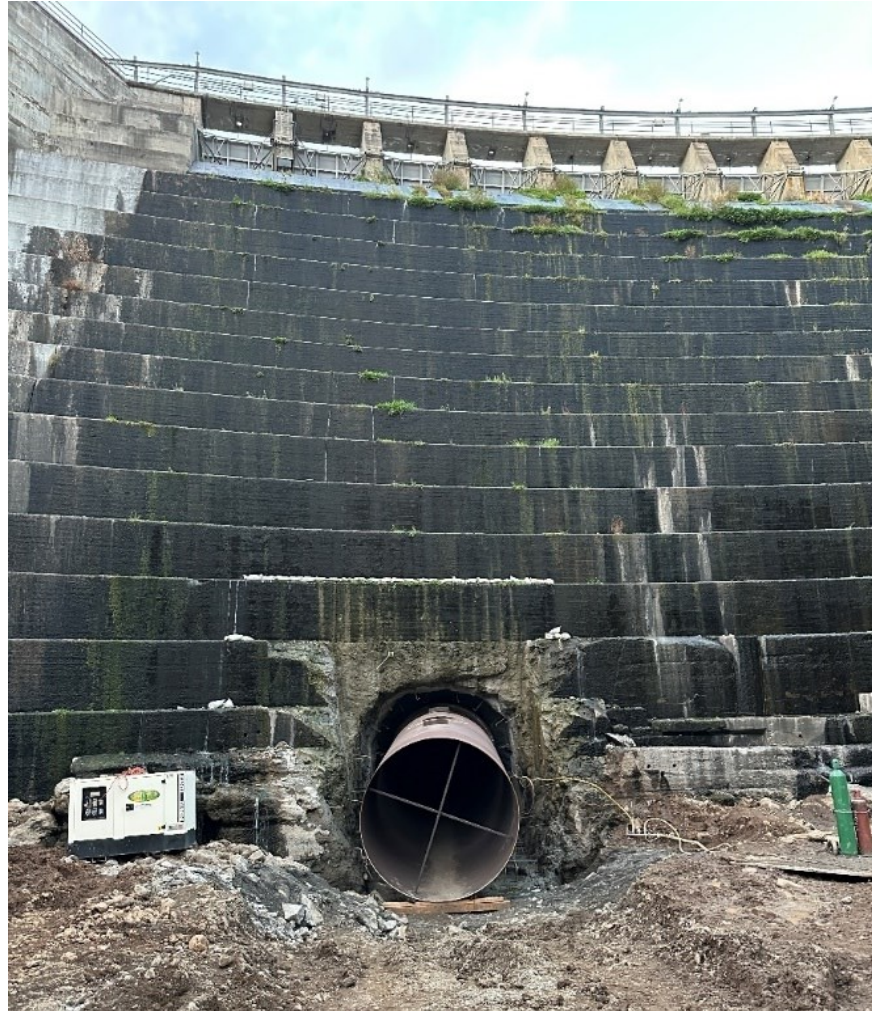
First section of steel extension pipe set in place at the Copco 1 low-level adit.

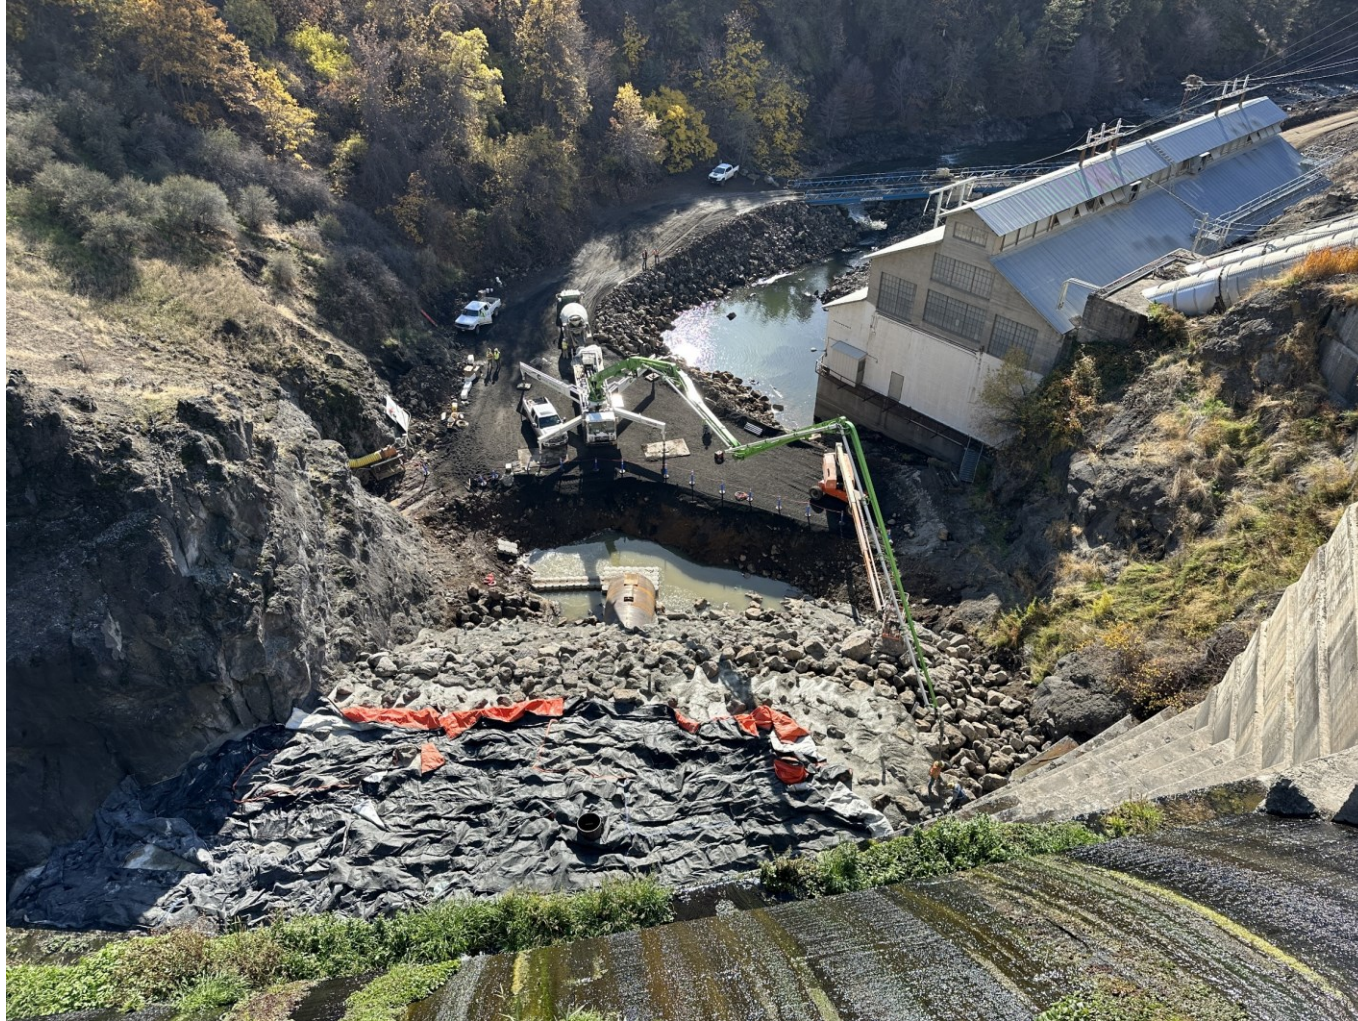
General view of Copco 1 dam and powerhouse with progress on grouted riprap placement over the steel extension pipe.
8 November 2023

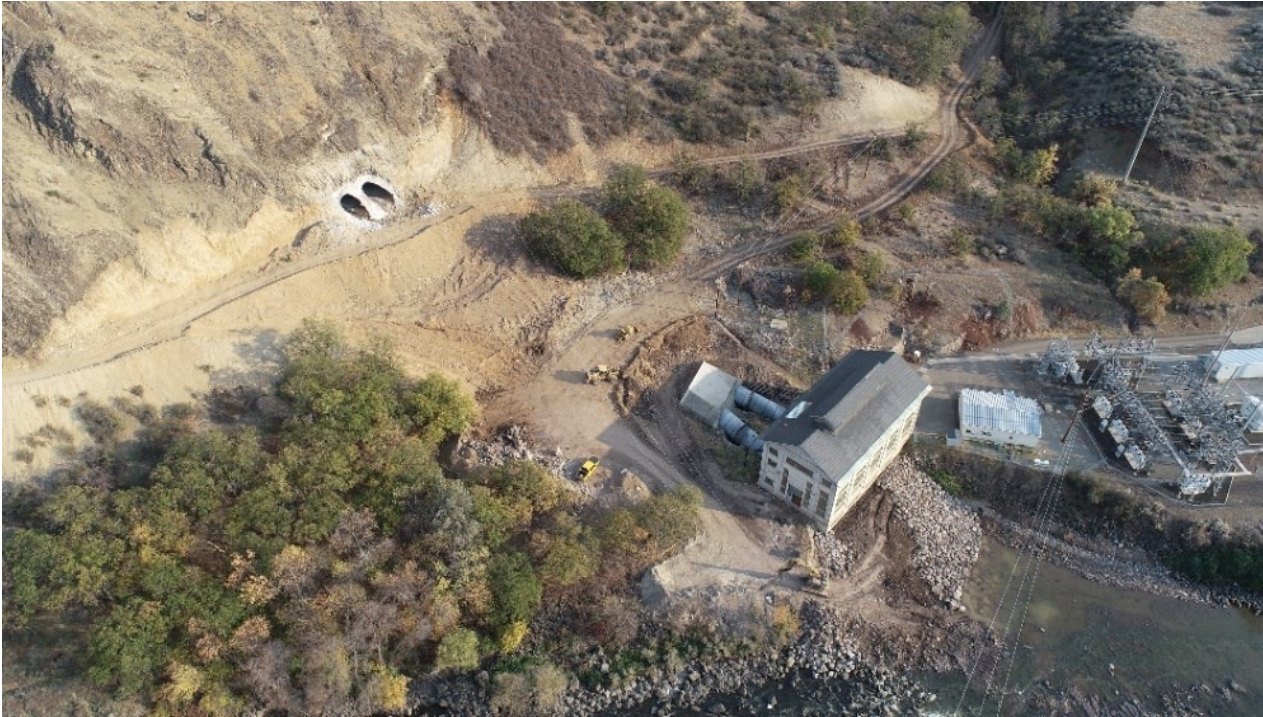
Copco 2 steel penstock thrust blocks have been removed.
Lower thrust block backfilled.
1 November 2023

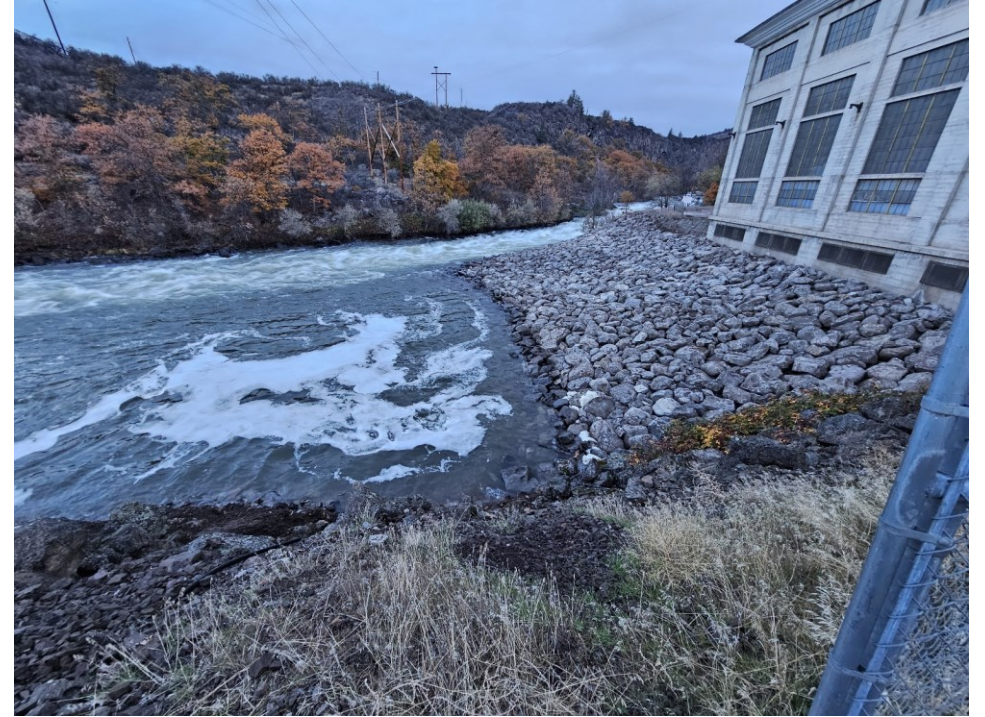
Copco 2 tailrace backfilled with rip rap
11 November 2023

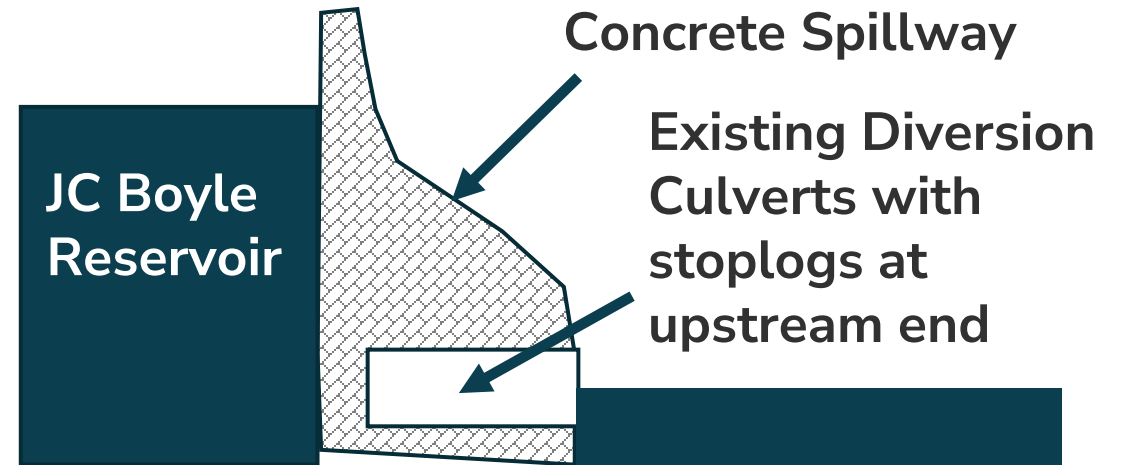
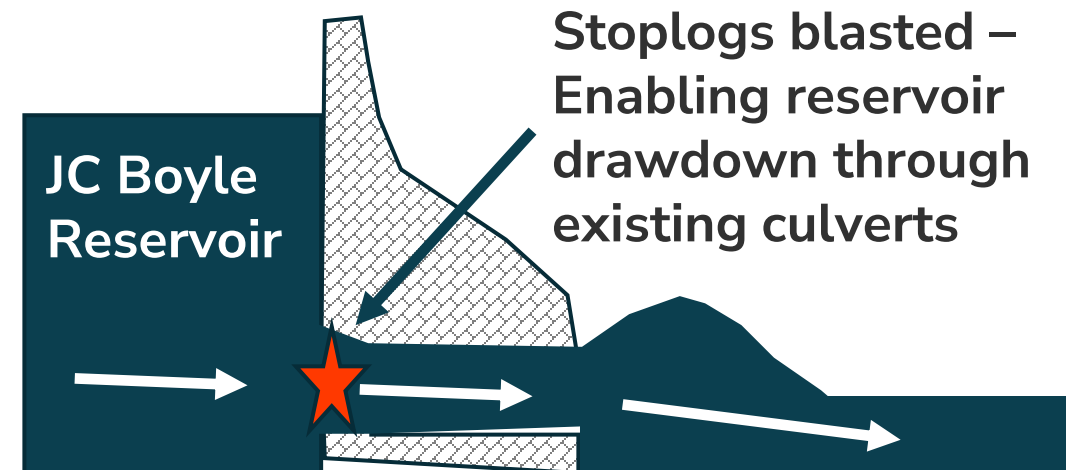
JC Boyle Reservoir Drawdown & Dam Removal

- 1) JC Boyle reservoir was drawn down in January 2024. Existing culverts underneath the dam (which were used to divert water during original construction) were opened to provide a low-level outlet at the spillway.
- 2) Stoplogs (a thin concrete wall) that were at the upstream end of the diversion culverts were blasted out, allowing the reservoir to drawdown with water passing beneath the existing spillway.

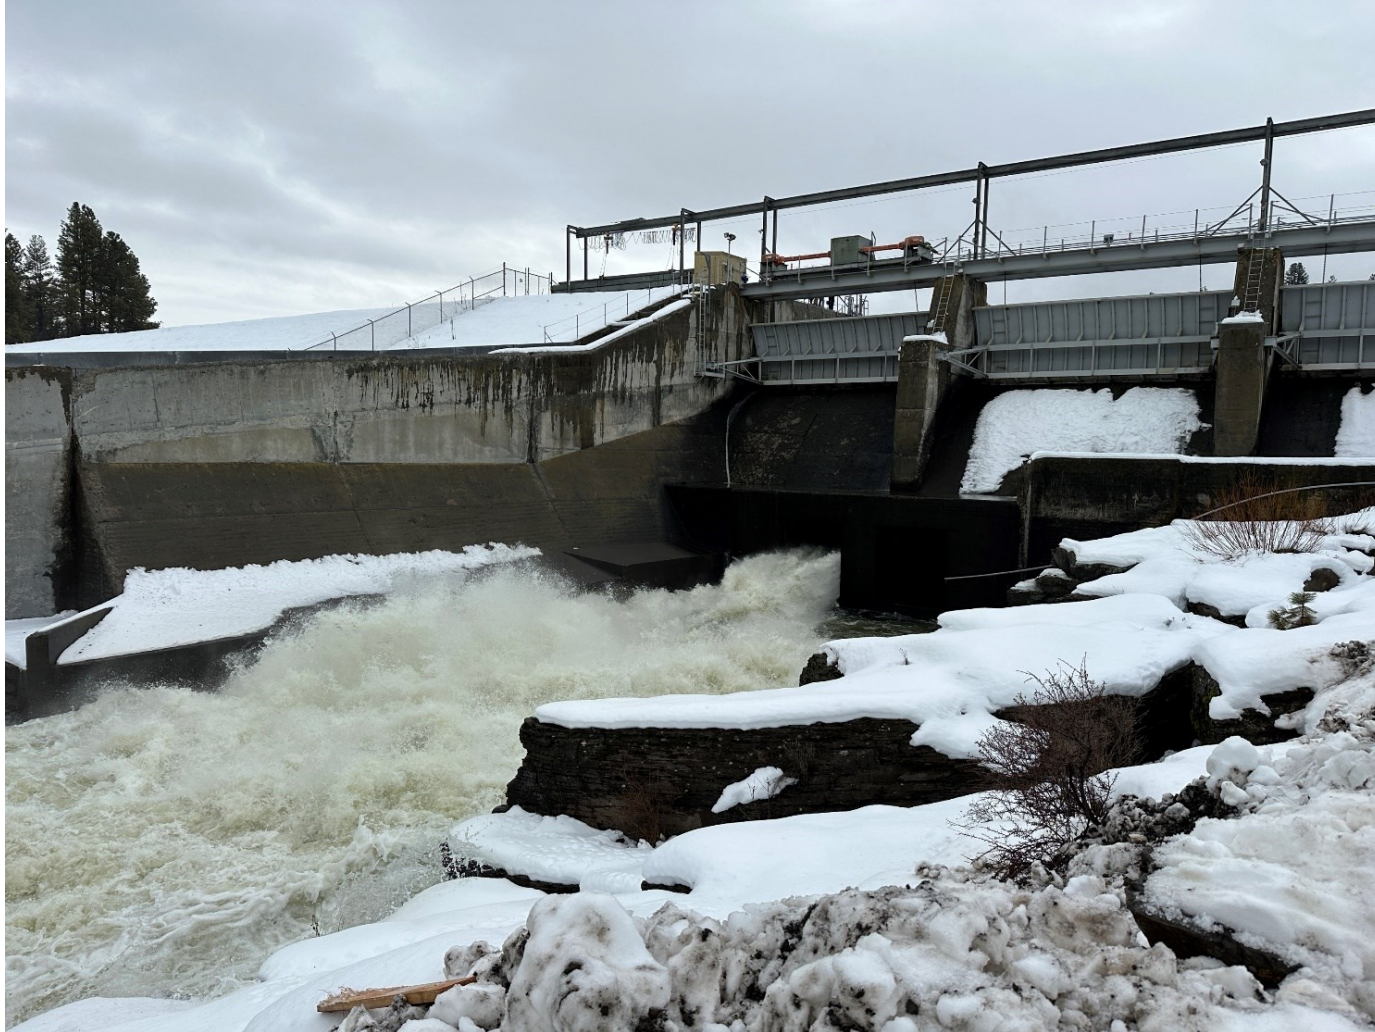
Reservoir drawdown initiated
after blasting the first diversion
culvert.

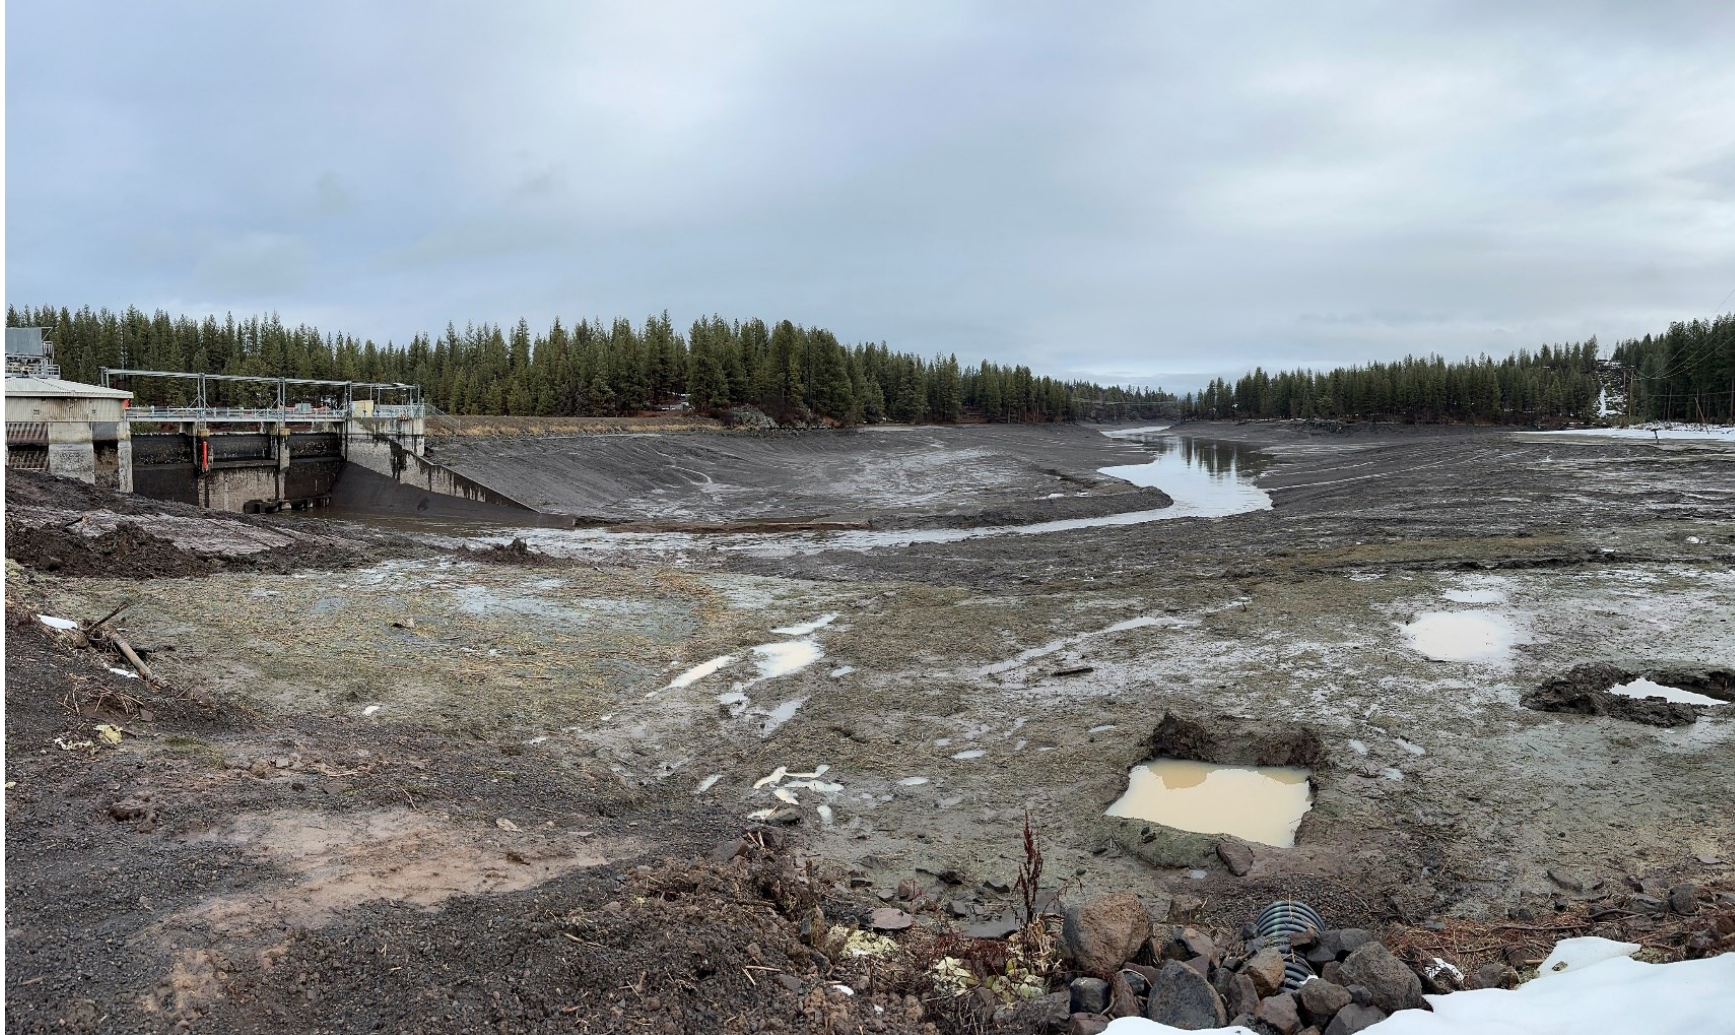
JC Boyle reservoir drawdown complete. Historic cofferdam located in the center of the image. 1200 cfs flushing flow in progress.

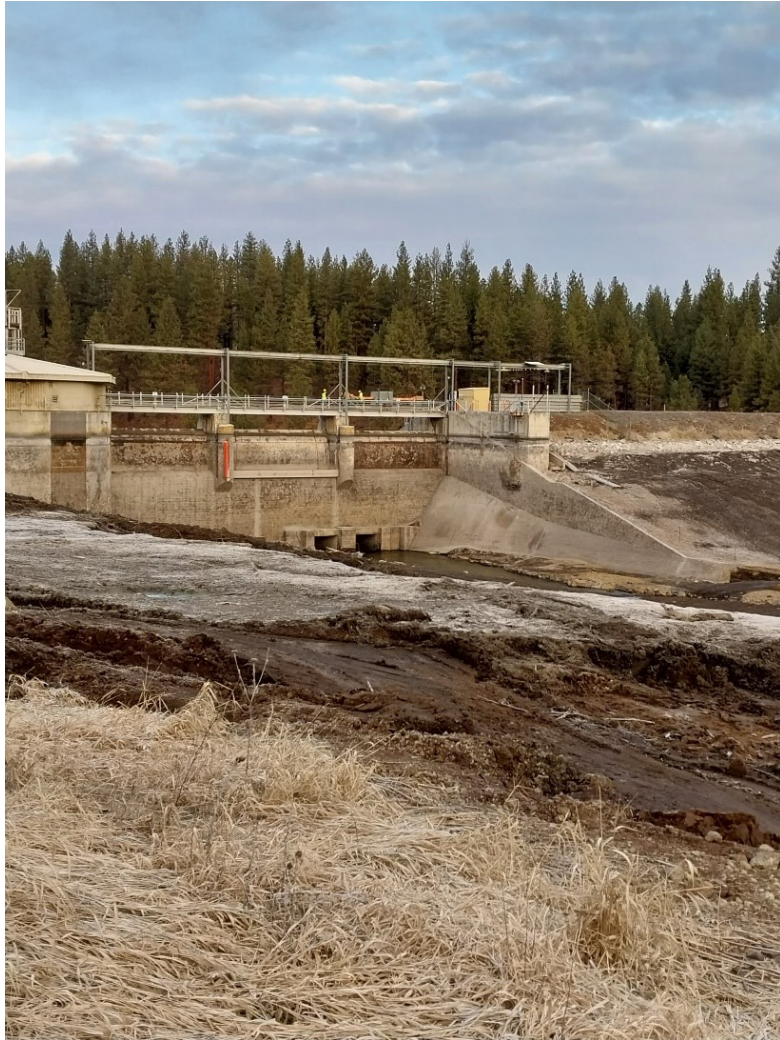
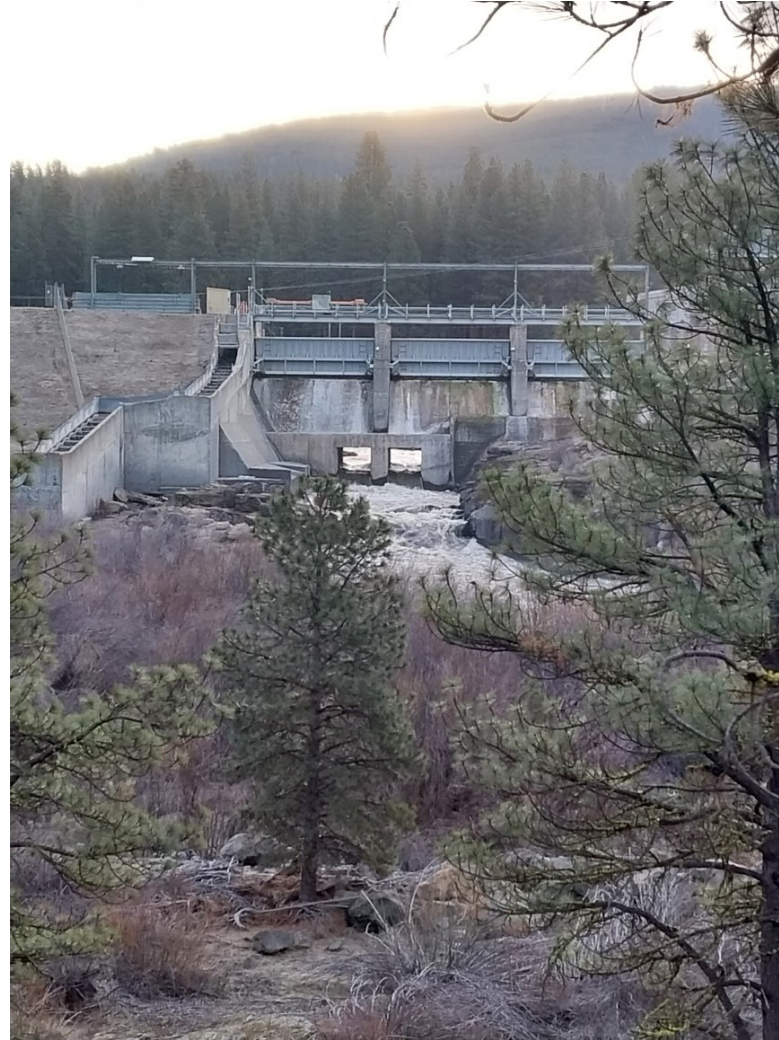
JC Boyle reservoir
drawdown complete.
Spillway conduits fully
open.

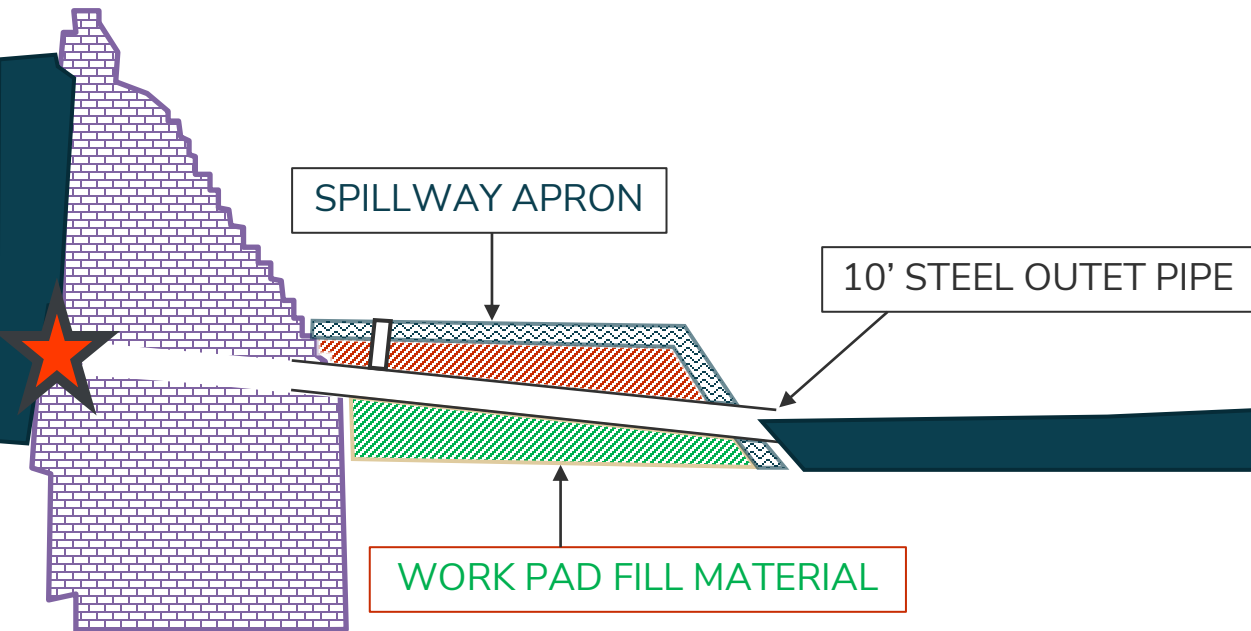
1) Plug concrete at upstream end of tunnel blasted and removed

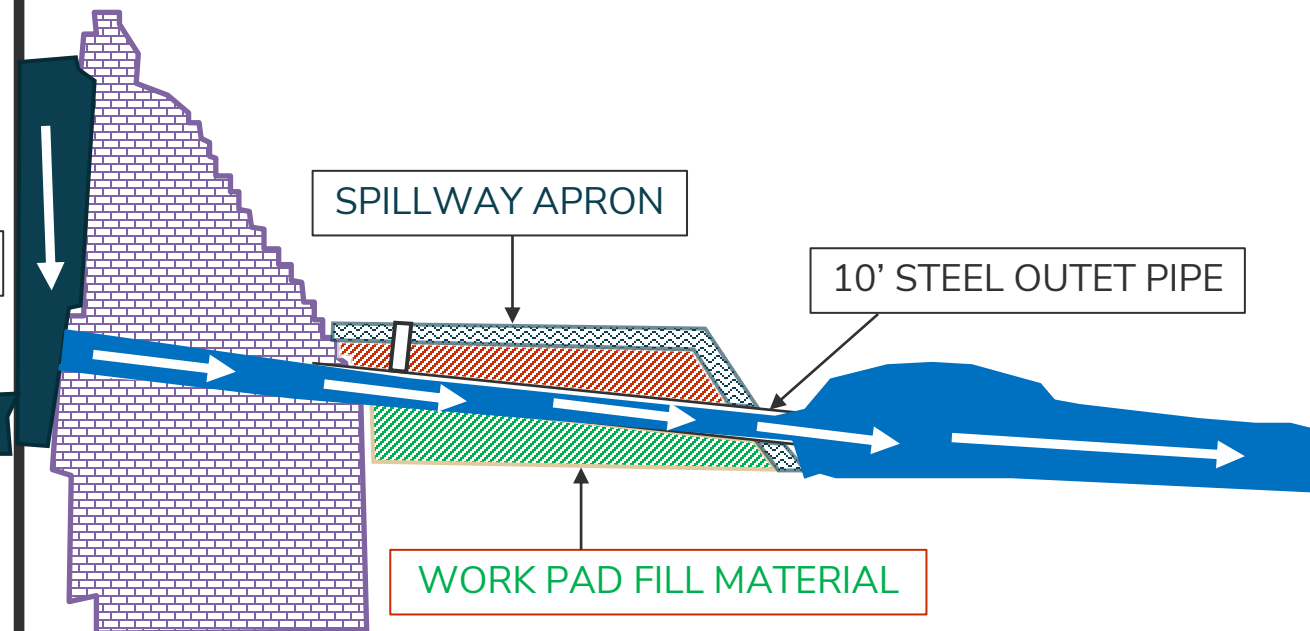
2) Copco 1 reservoir drained through adit tunnel and extension pipe

3) Following reservoir drawdown—Copco 1 Dam will be removed by drilling and blasting, and a new river channel will be built in the existing dam footprint. The new channel is expected to be complete by October 2024.

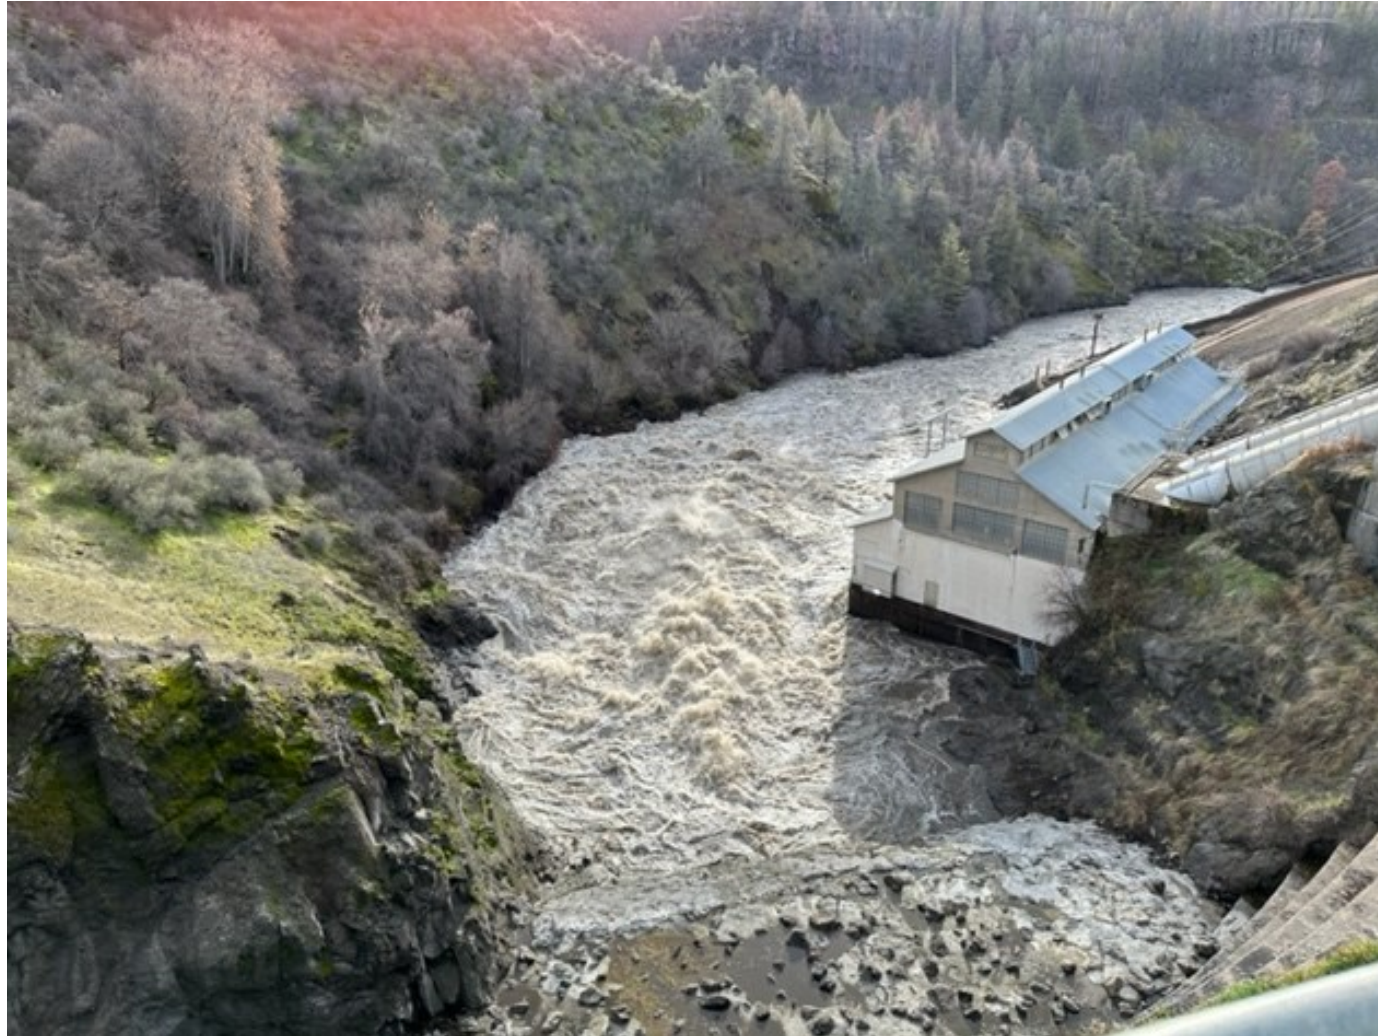
View of Copco No. 1
Powerhouse and river channel
after adit plug blasted
23 January 2024

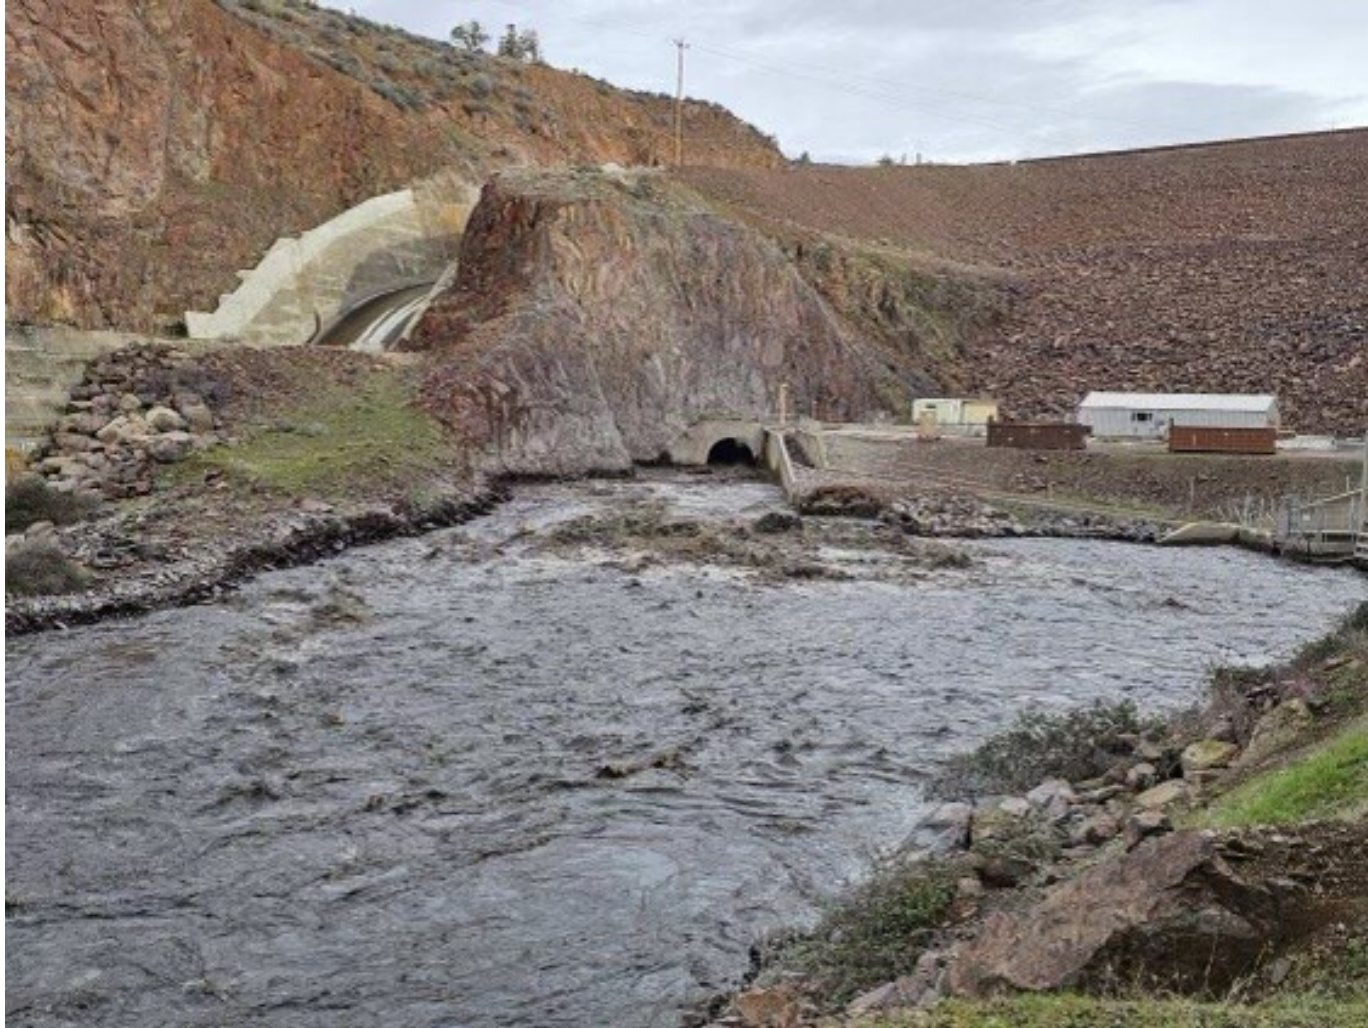
Klamath River at Low
Level Outlet tunnel.
5 February 2024

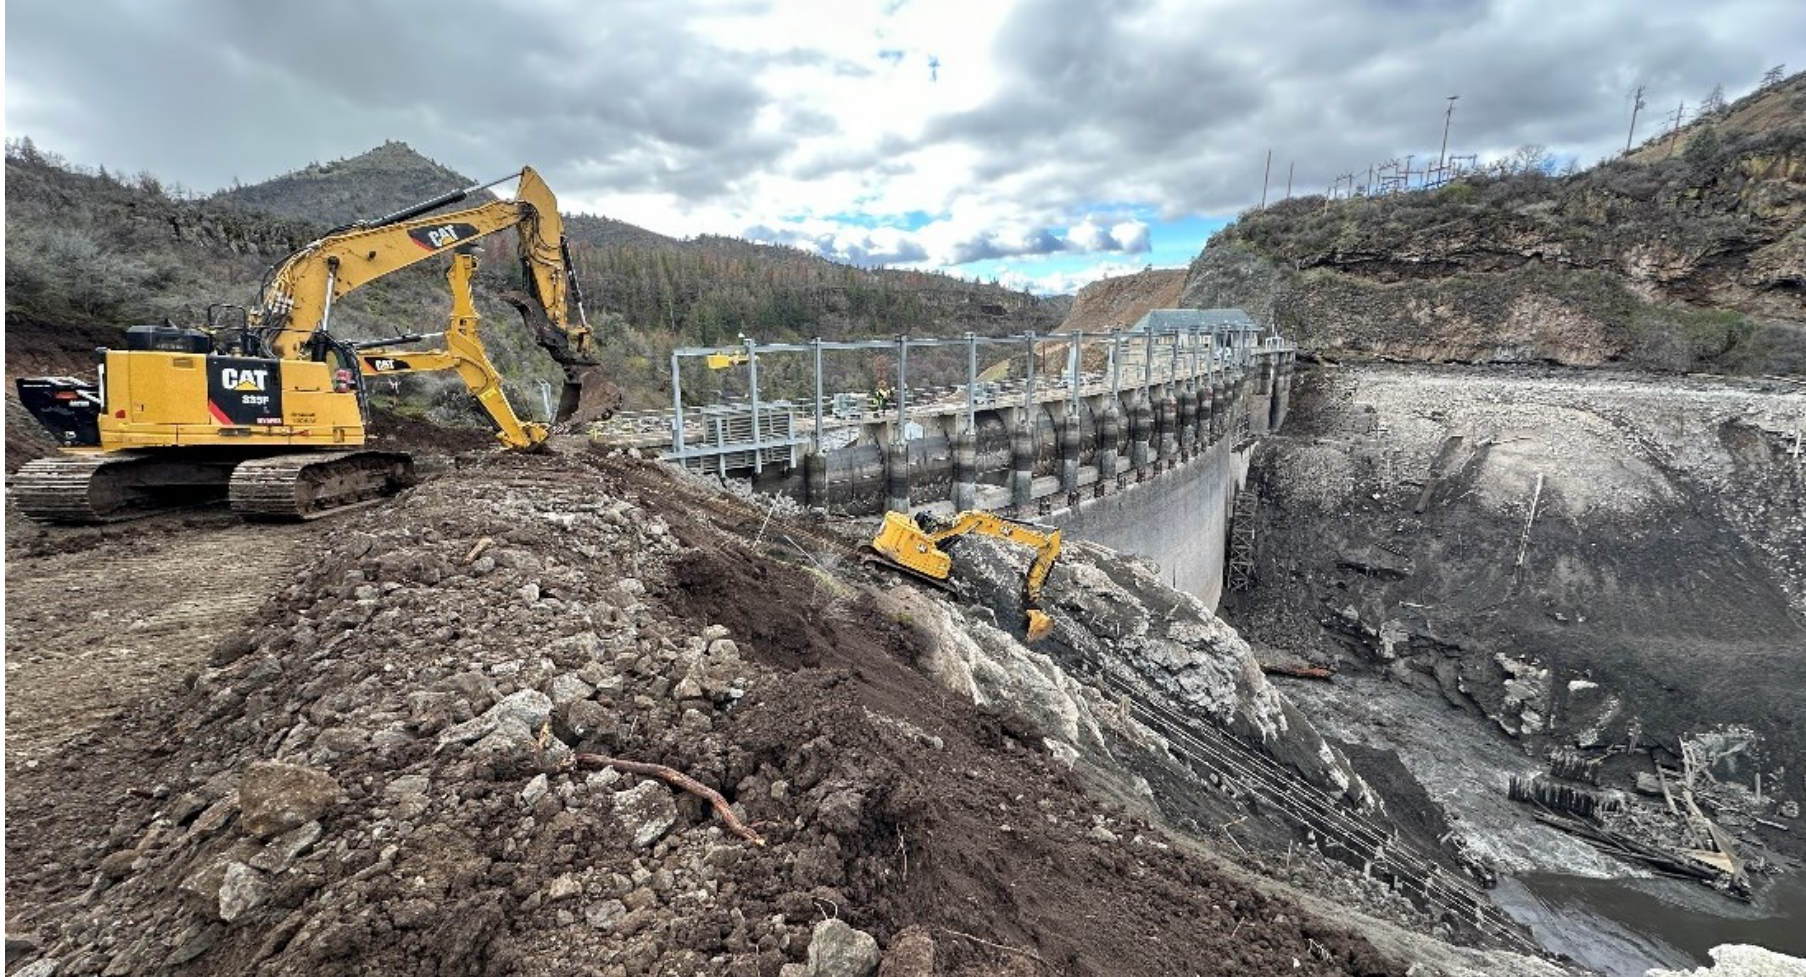
Tractionline winched excavator removing diversion tunnel gate operator concrete piers at Copco 1.

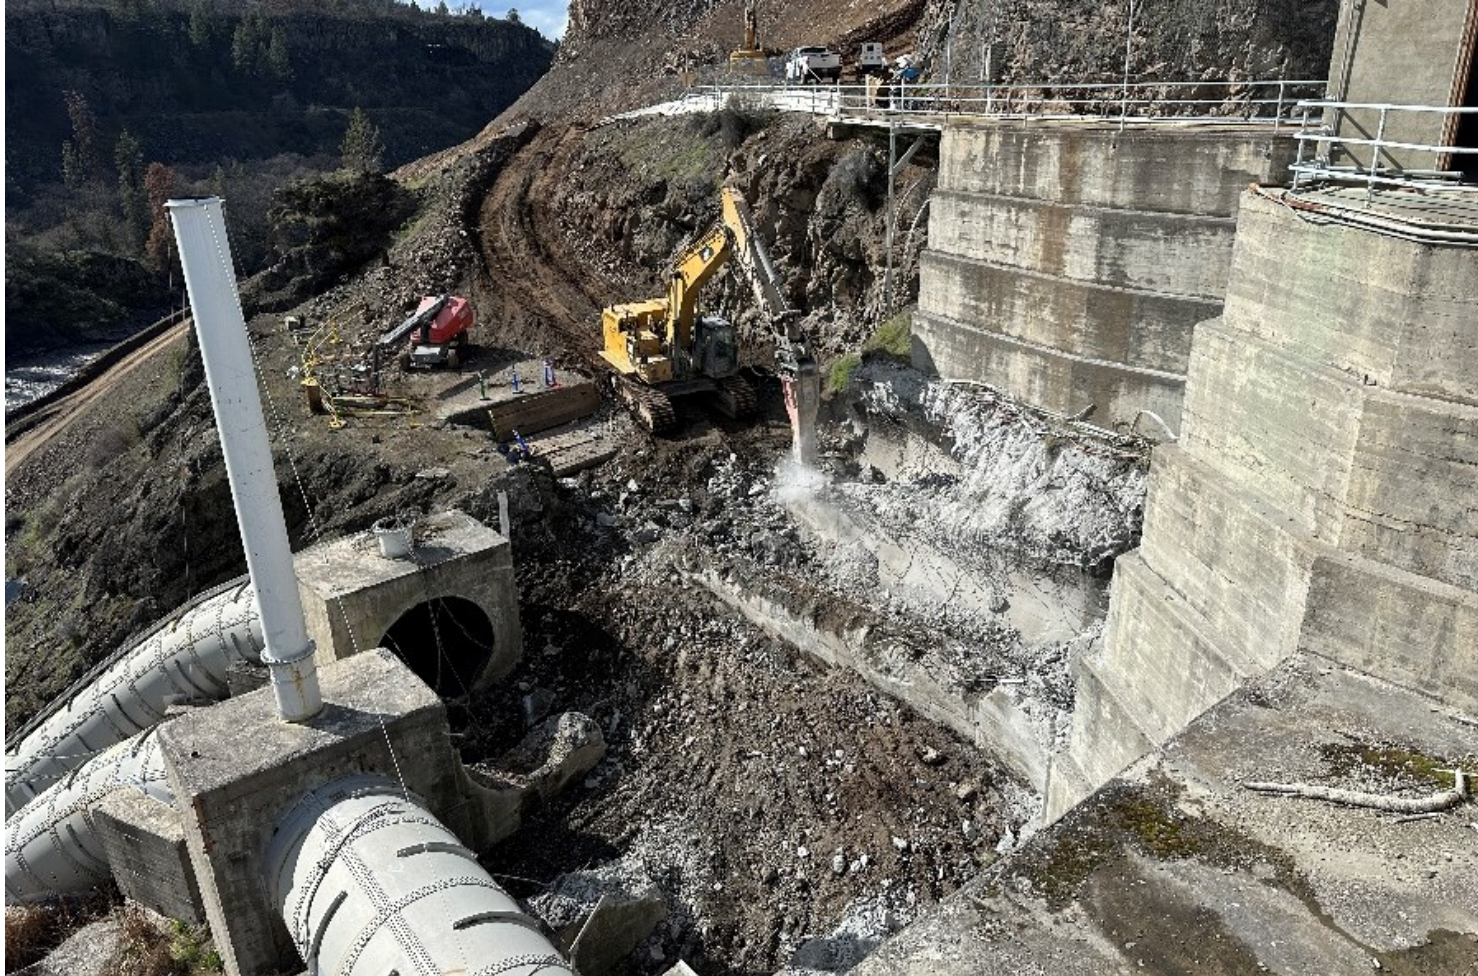
Copco 1 penstock
removal in progress in
preparation for U500
road.
