KLAMATH RIVER RENEWAL PROJECT:

Planning & Implementation for Complex Dam Removal

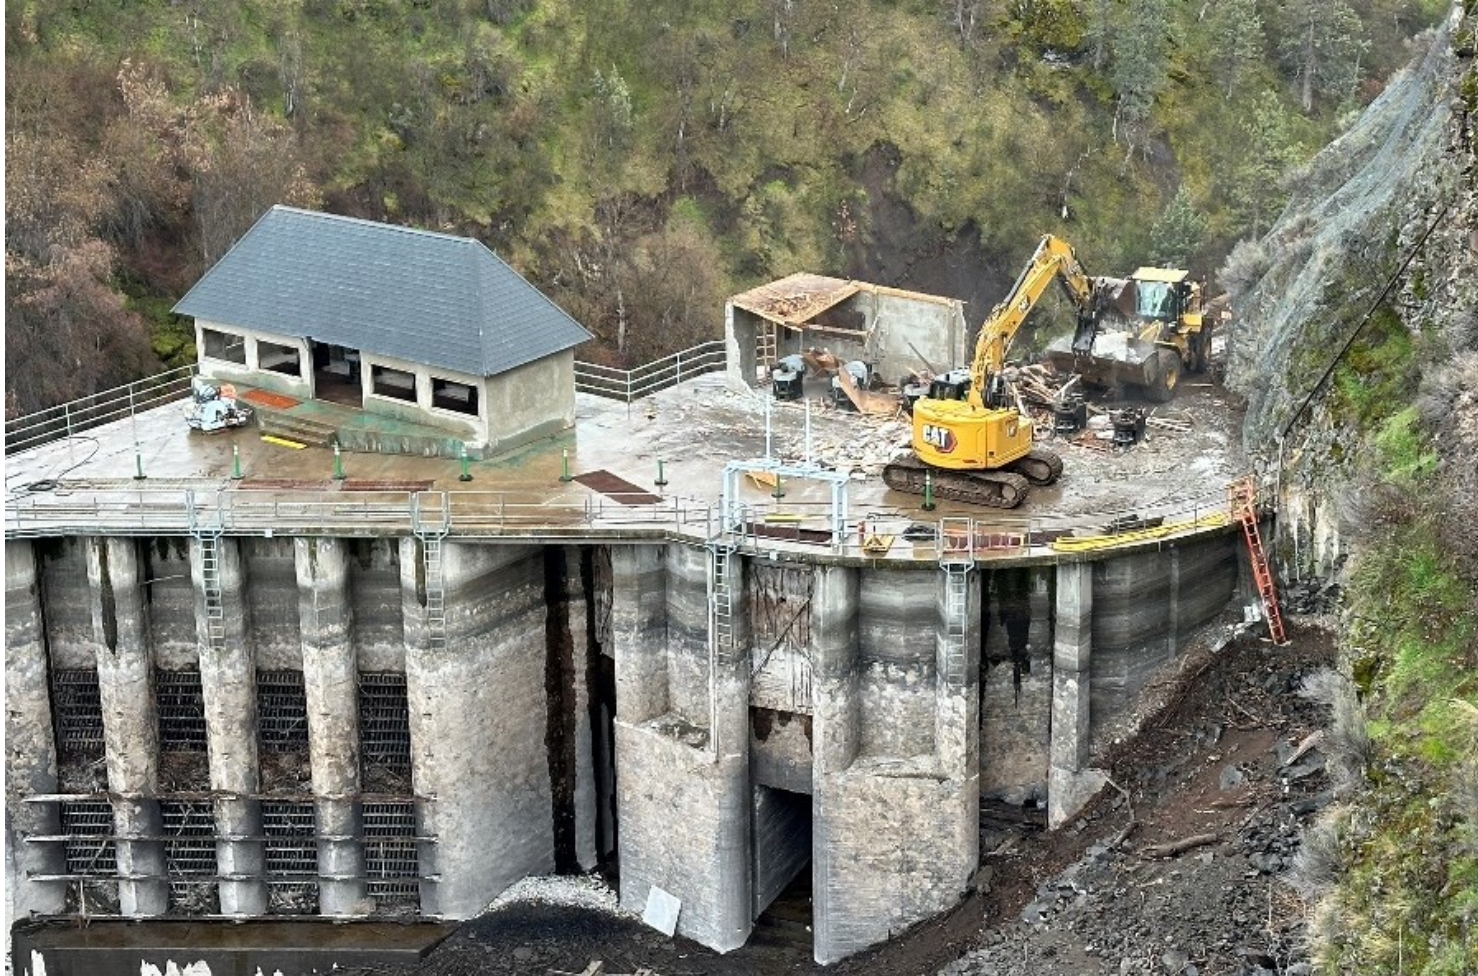
Demolishing the Copco 1
intake gatehouses.

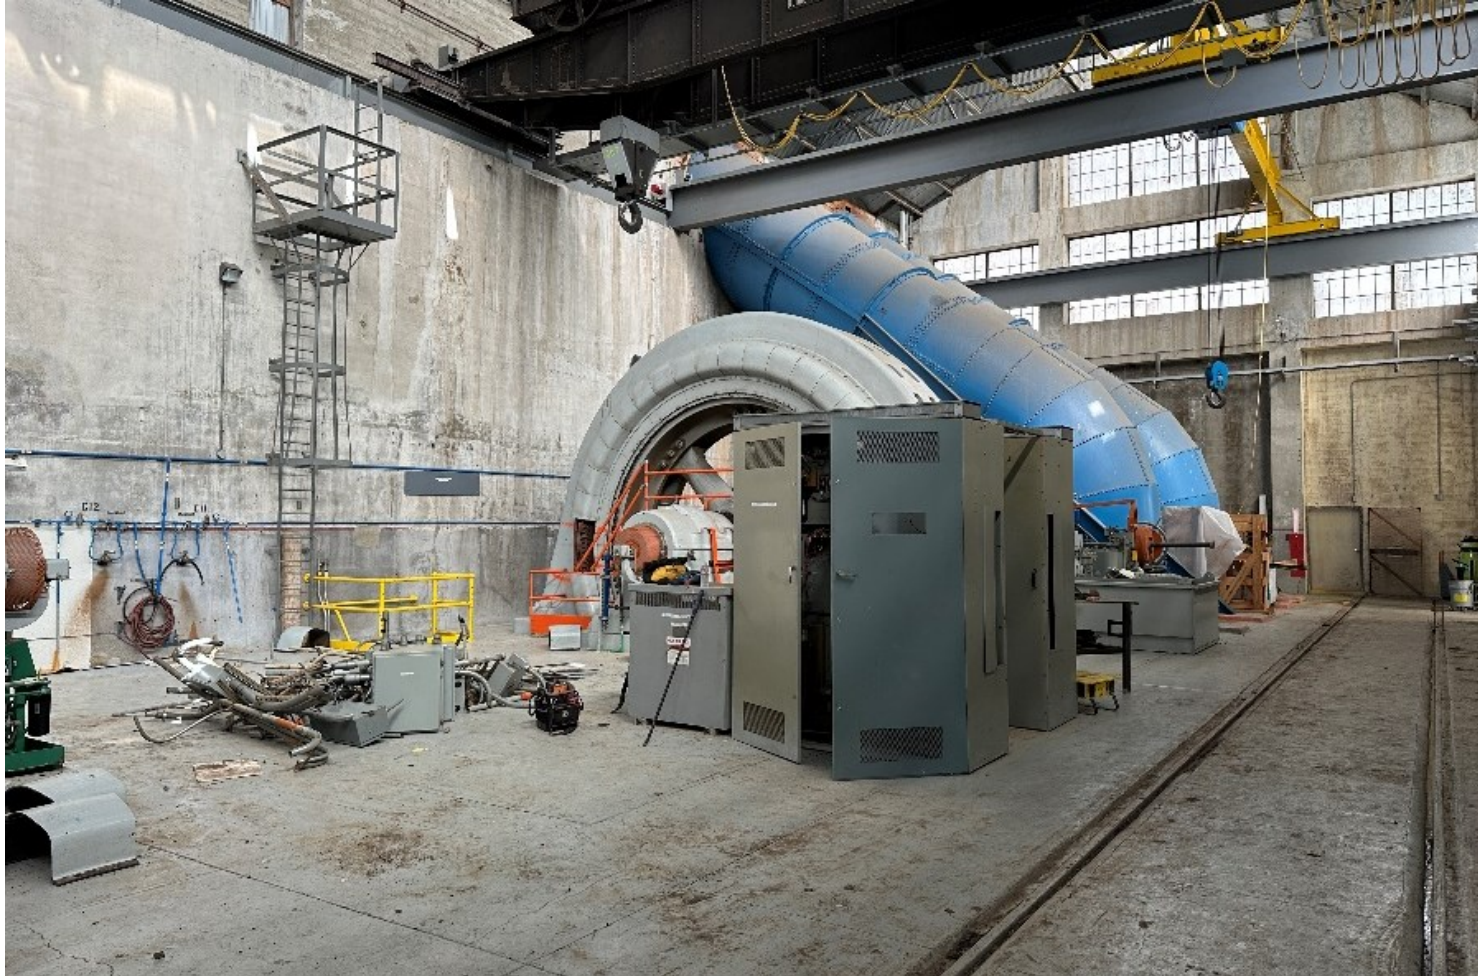
Mechanical and electrical
demo in progress at
Copco 1 powerhouse.
22 February 2024

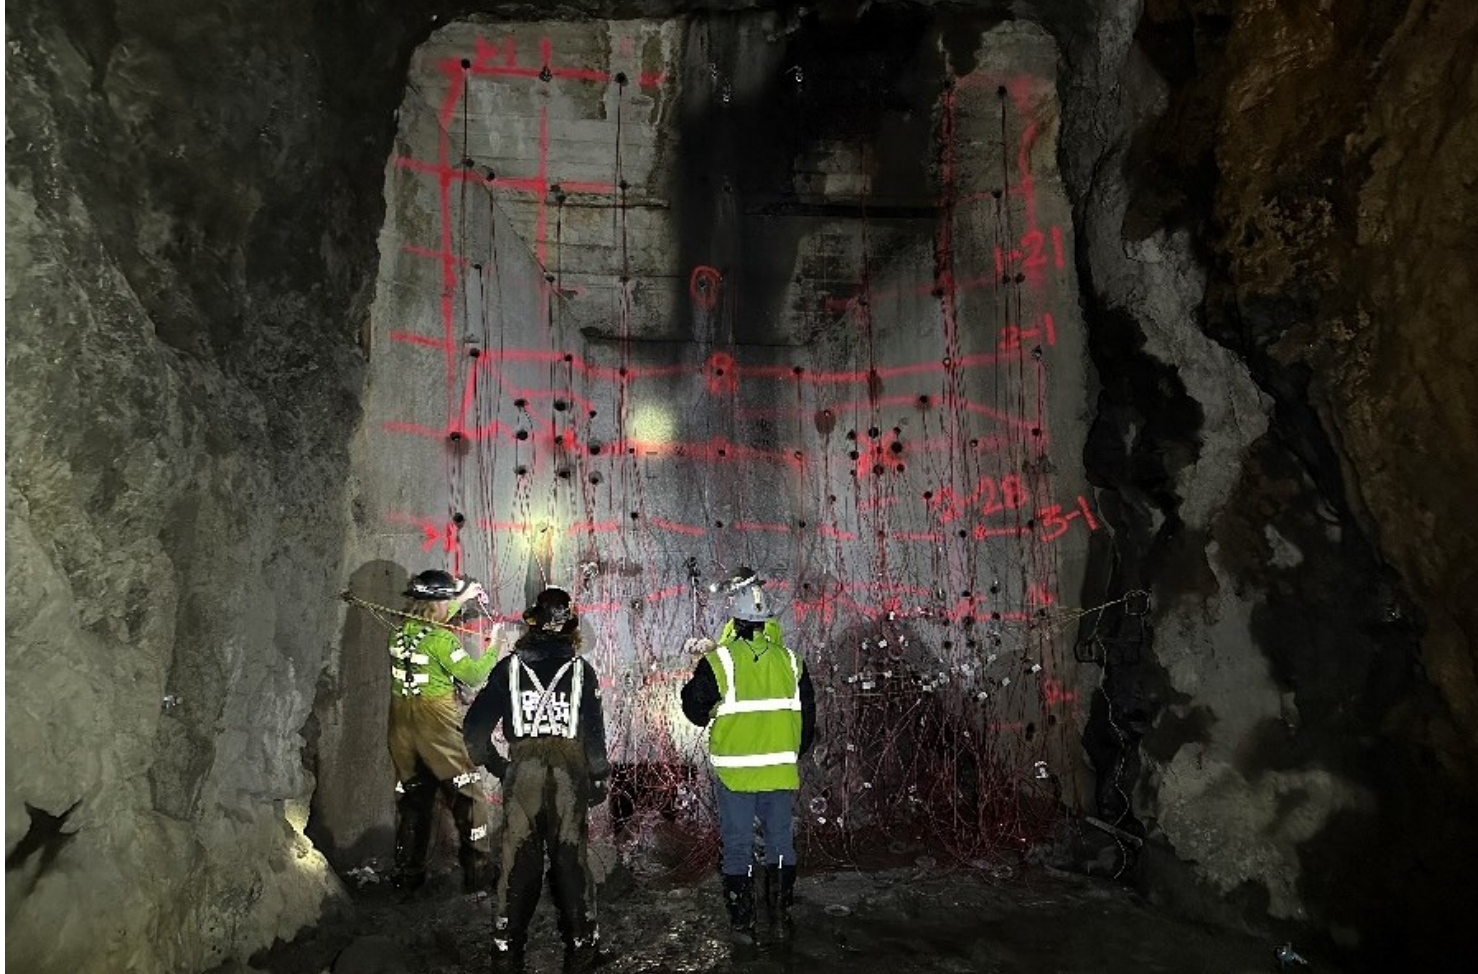
Copco 1 diversion tunnel
plug loaded and tied in.

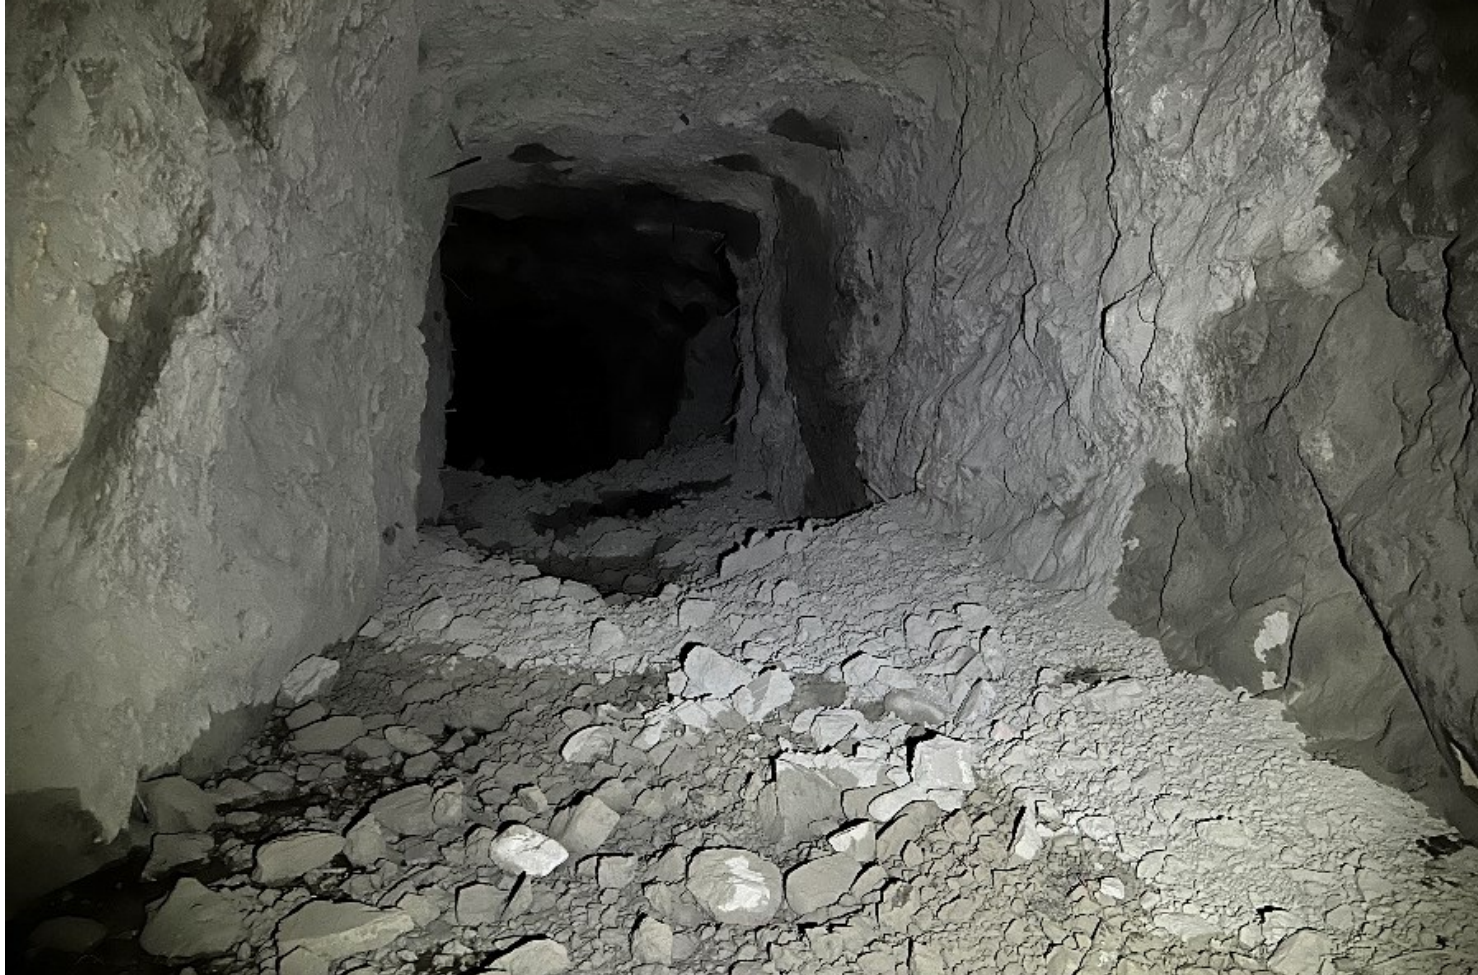
Copco 1 diversion tunnel
after blasting the plug.

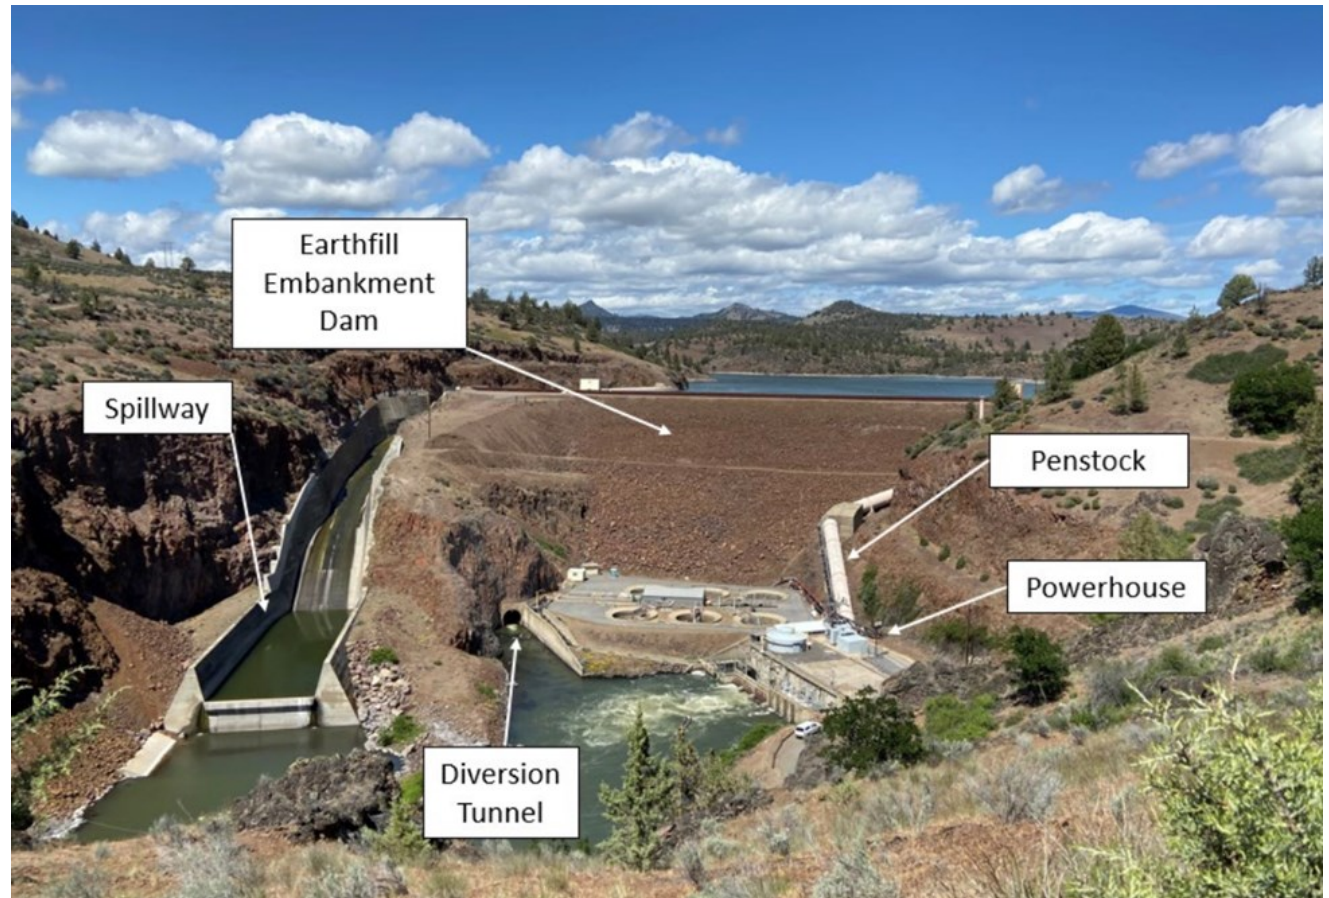
2024 Reservoir Drawdown & Dam Removal: Iron Gate

- Drawdown of Irongate Reservoir is using the existing low level outlet diversion tunnel.
- Beginning in approximately May/June of 2024, large trucks and excavation equipment will remove the dam embankment from the top down
- Approximately 1 million cubic yards will be excavated in total
- The existing spillway will be filled in with earthen materials
- The powerhouse equipment will be removed and the powerhouse demolished
- Once the dam and facilities are removed, a new river channel will be built in the dam footprint. This channel grading is expected to be completed by October 2024

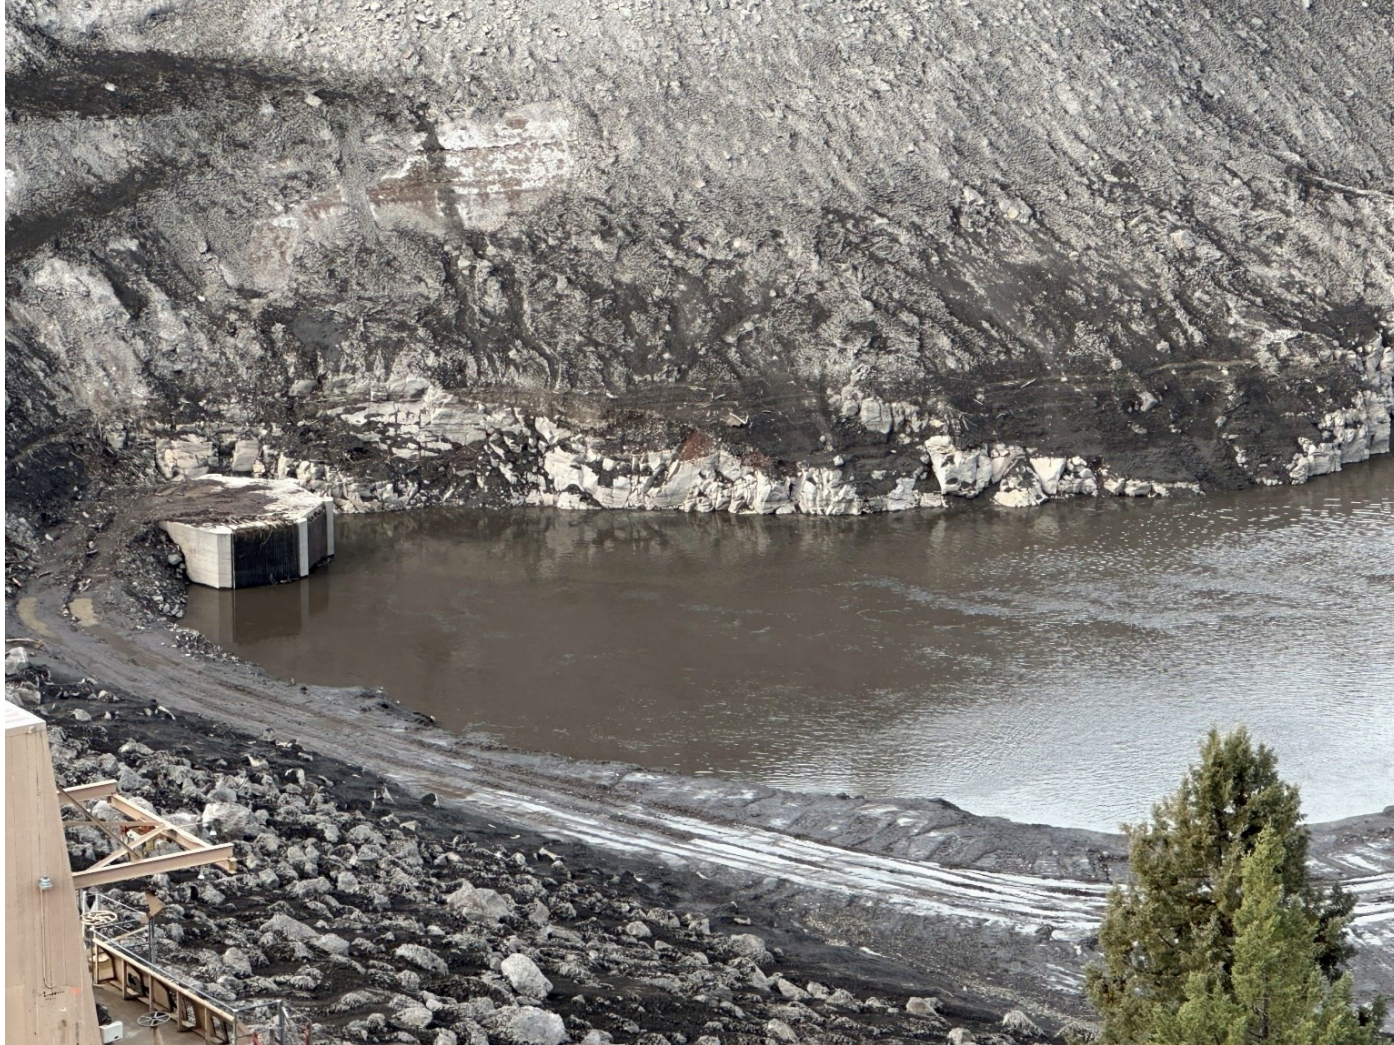
Exposed diversion tunnel intake
structure trash racks at Iron Gate.
12 March 2024

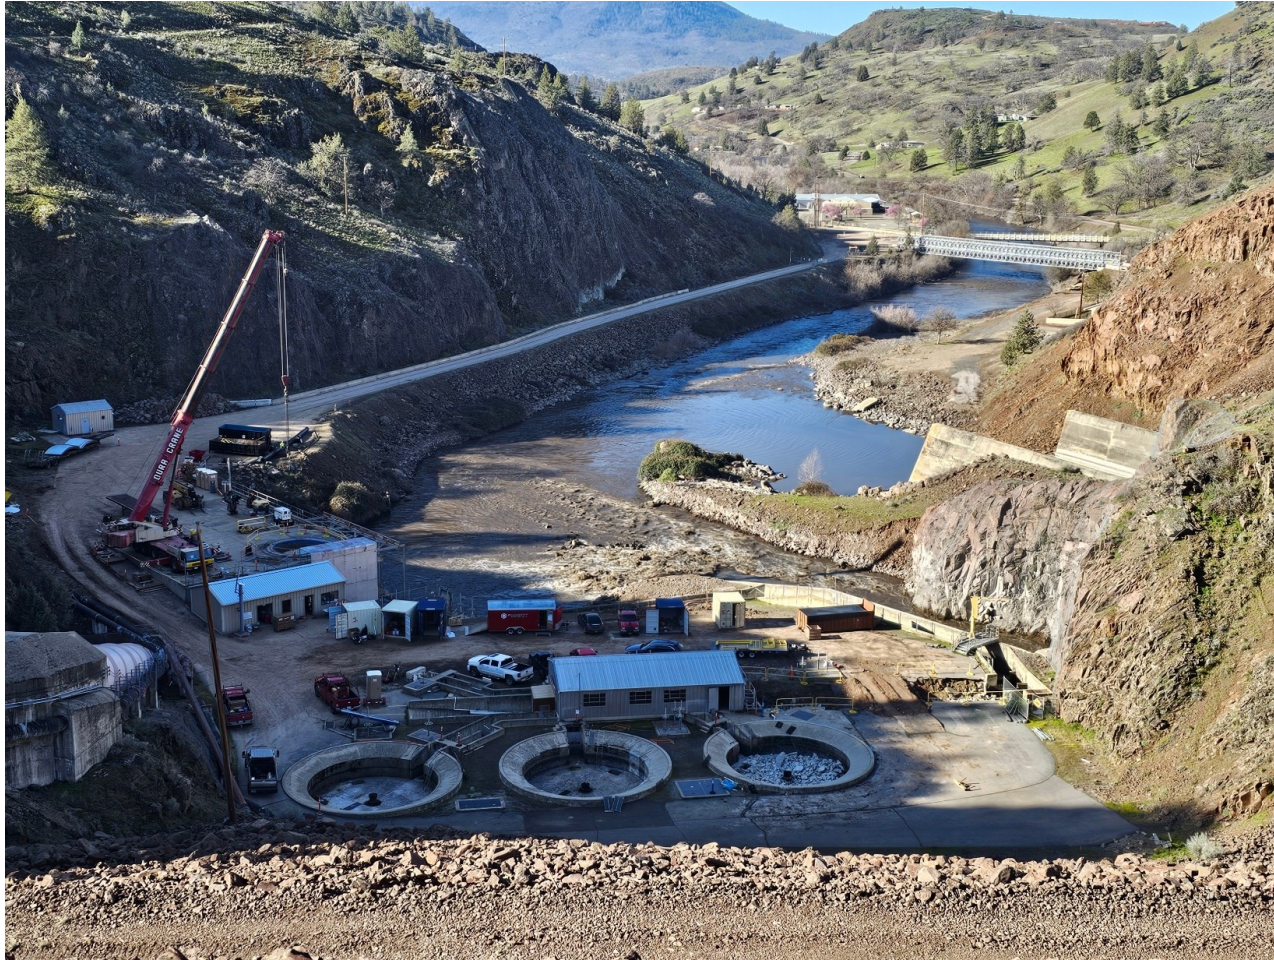
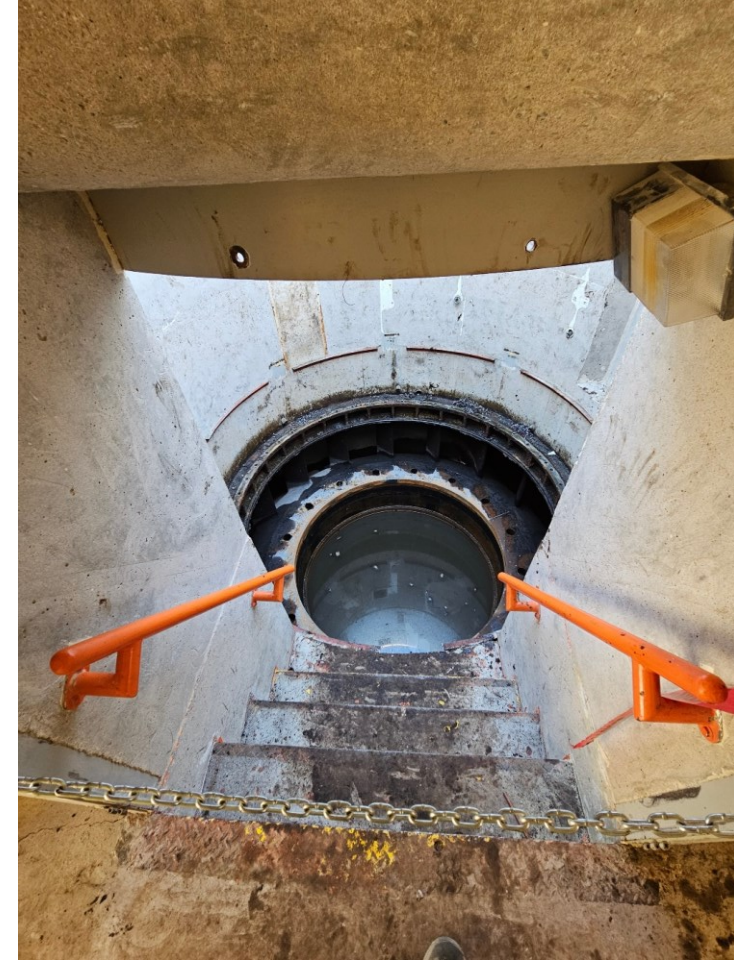
Removal of Iron Gate power generation equipment. 20 March
2024
