MONITORING RESULTS SHOW SLOW RECOVERY OF LAMPREY REPRODUCTION AFTER CONSTRUCTION OF A COUNTRY WISE FIRST NATURAL FISH PASSAGE

RĪVA RIVER

FISH PASSAGE

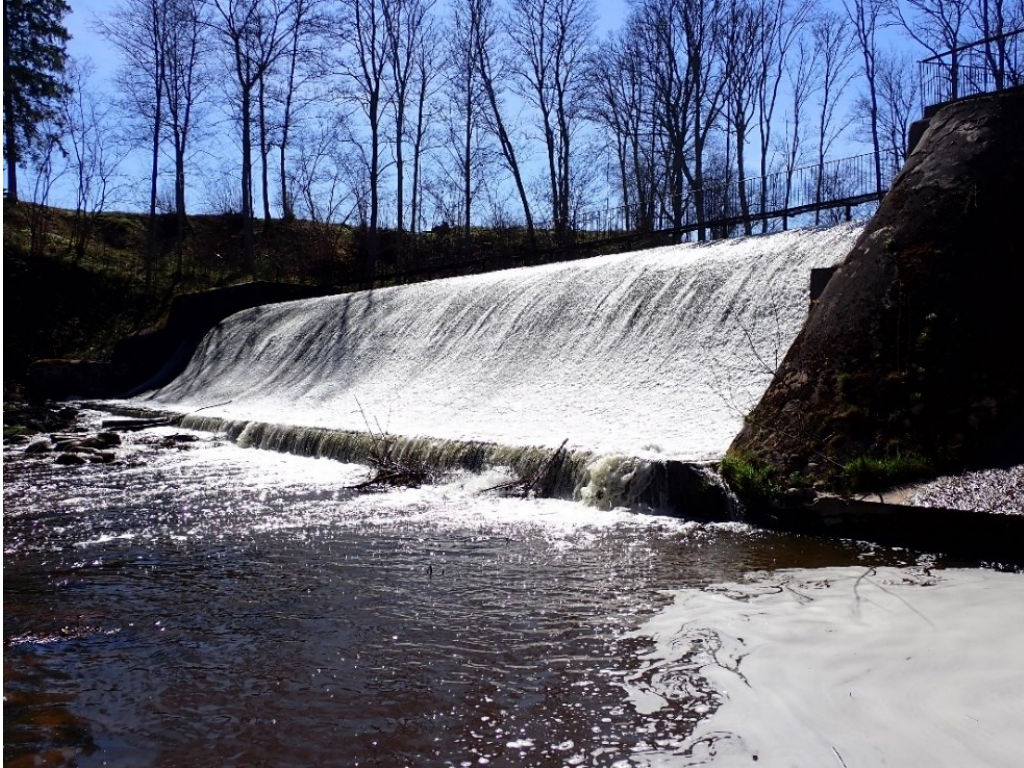
Lube mill on Roja river

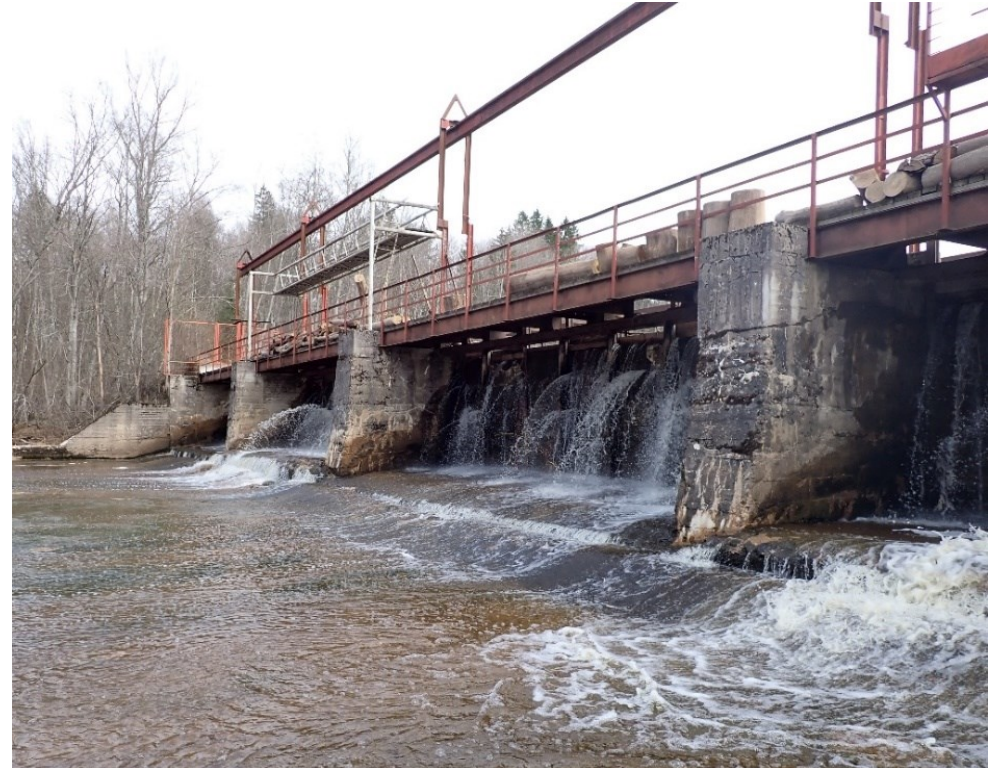
Vecogres HPP on Ogre river

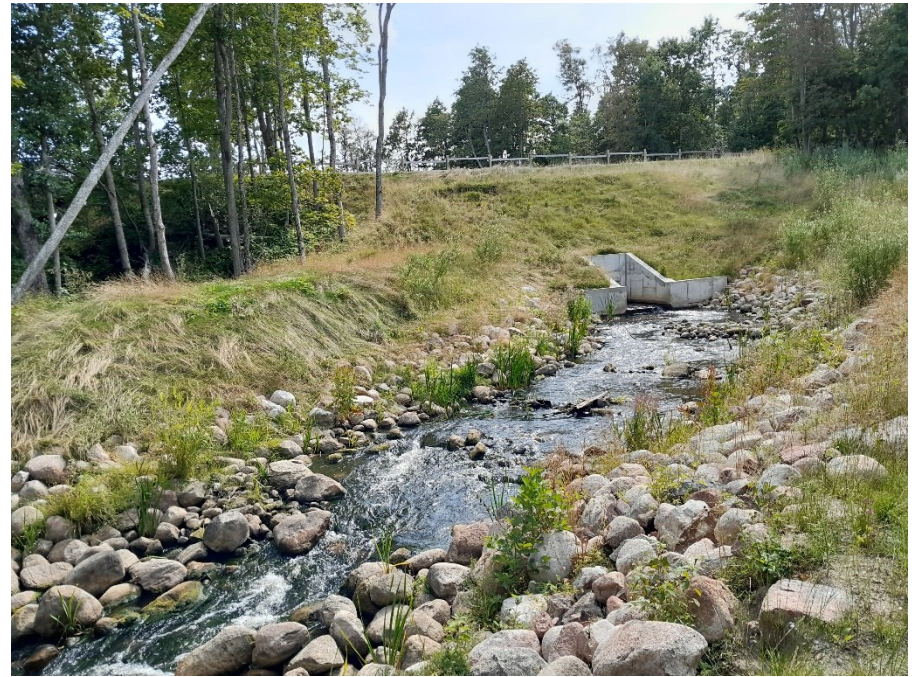
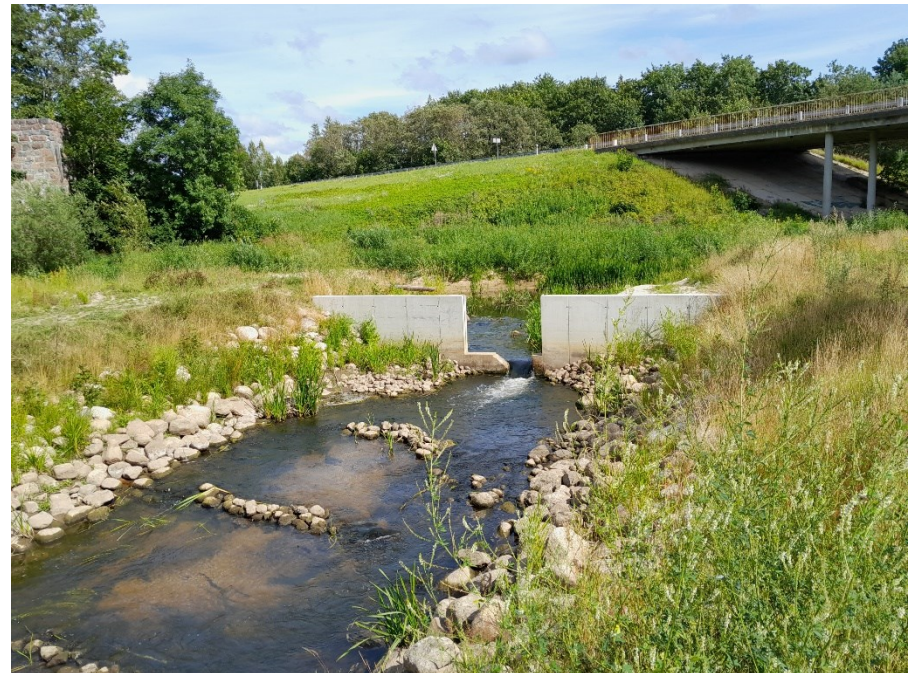
Built in 2020 within the RETROUT* project

Length 110 m, slope 20 m/km

Includes several reinforced concrete structures

The impact of the concrete structures on migration is unknown

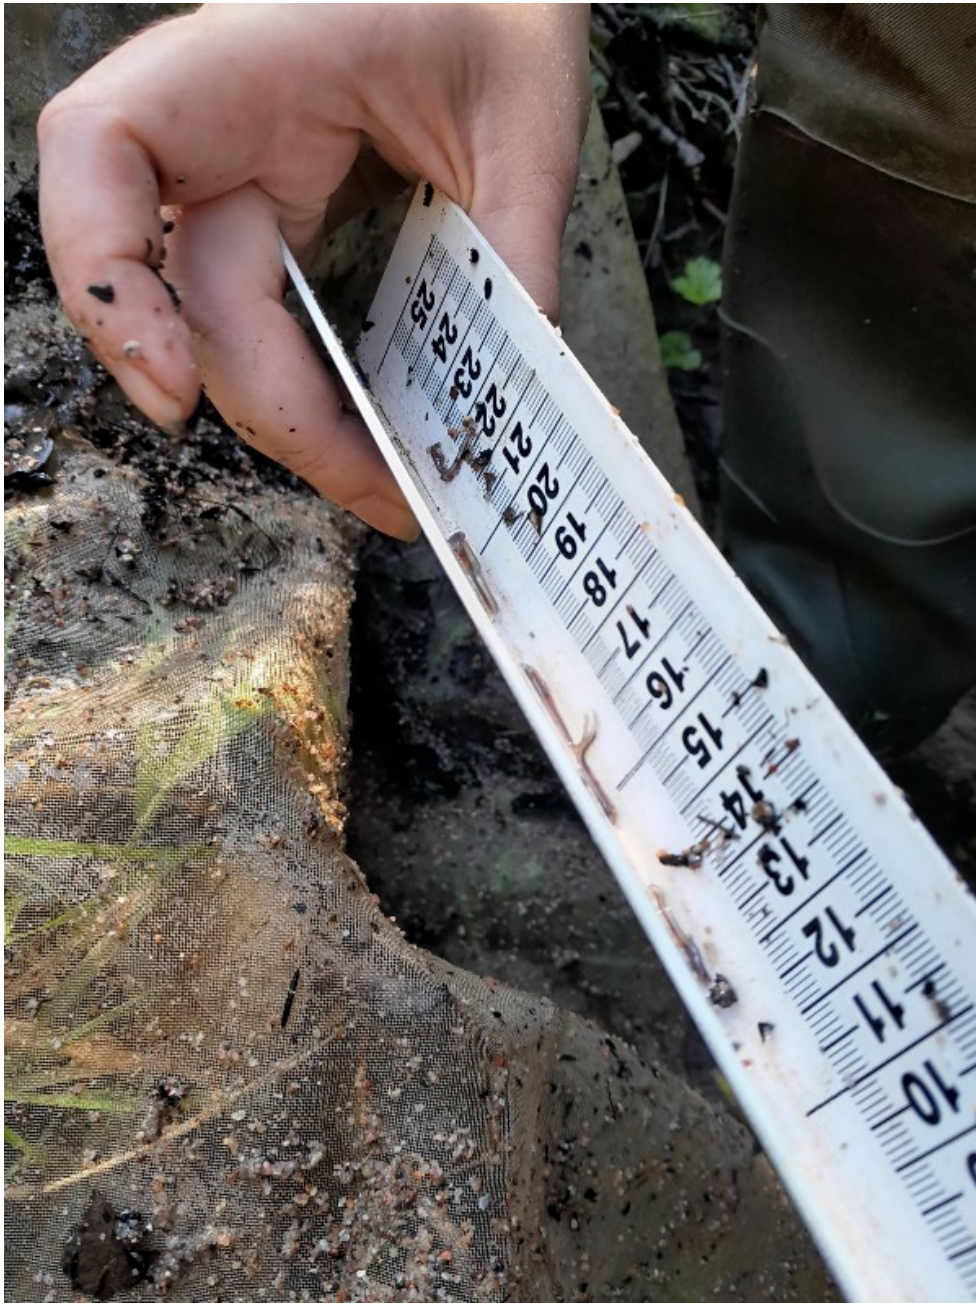
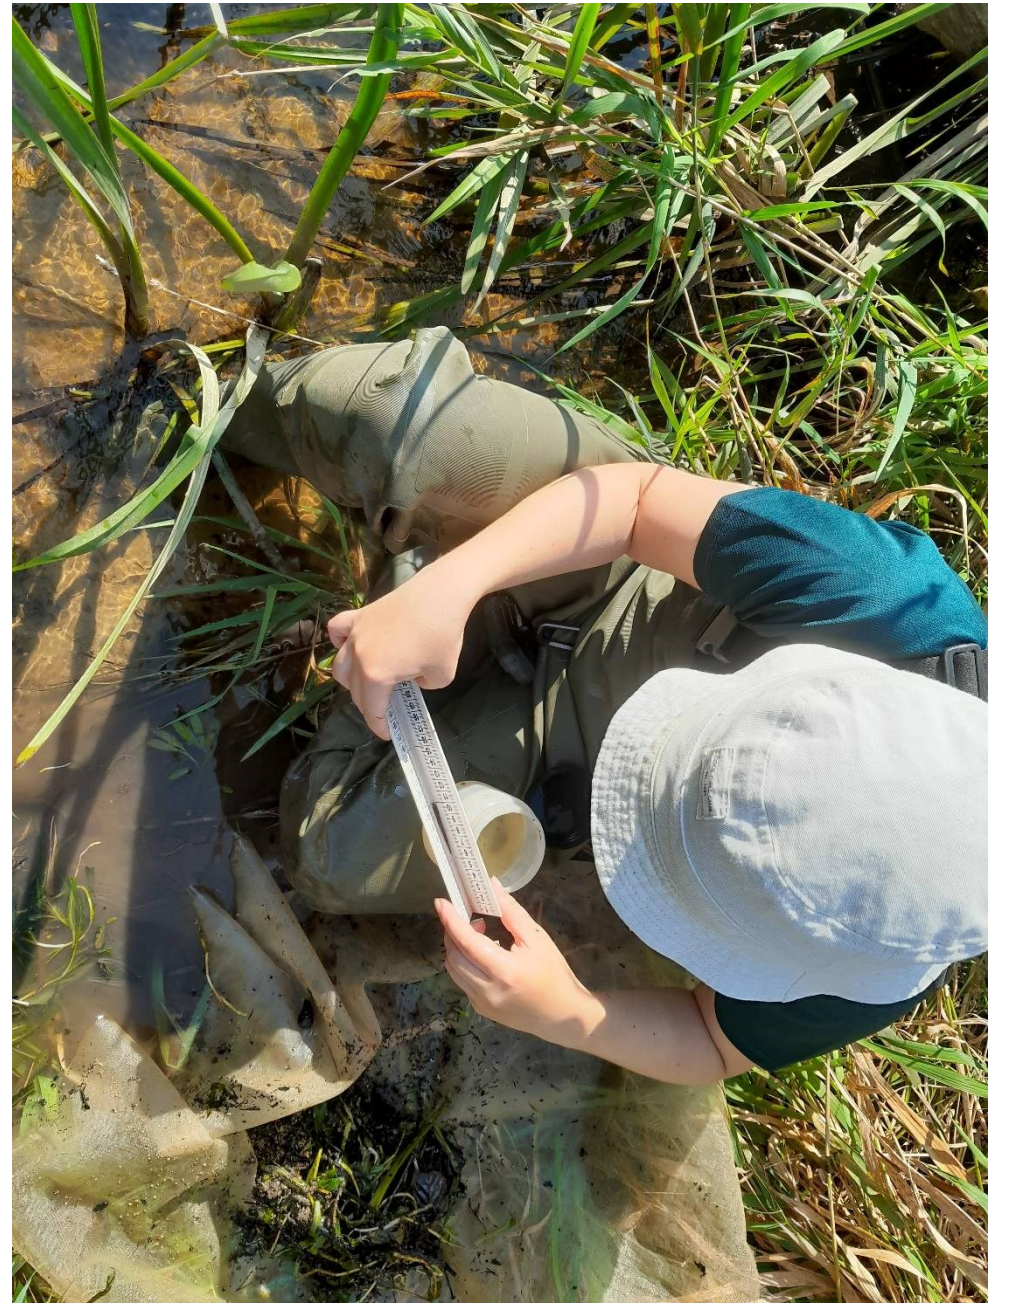
18 sampling sites, located 0.2–8.2 km upstream fish passage

Bottom sampling, stainless steel box (30 x 40 x 55 cm)

Length of the larvae (mm) was measured and age group (0+, 1+, >1+) was determined

After measurement the larvae were released back into the river

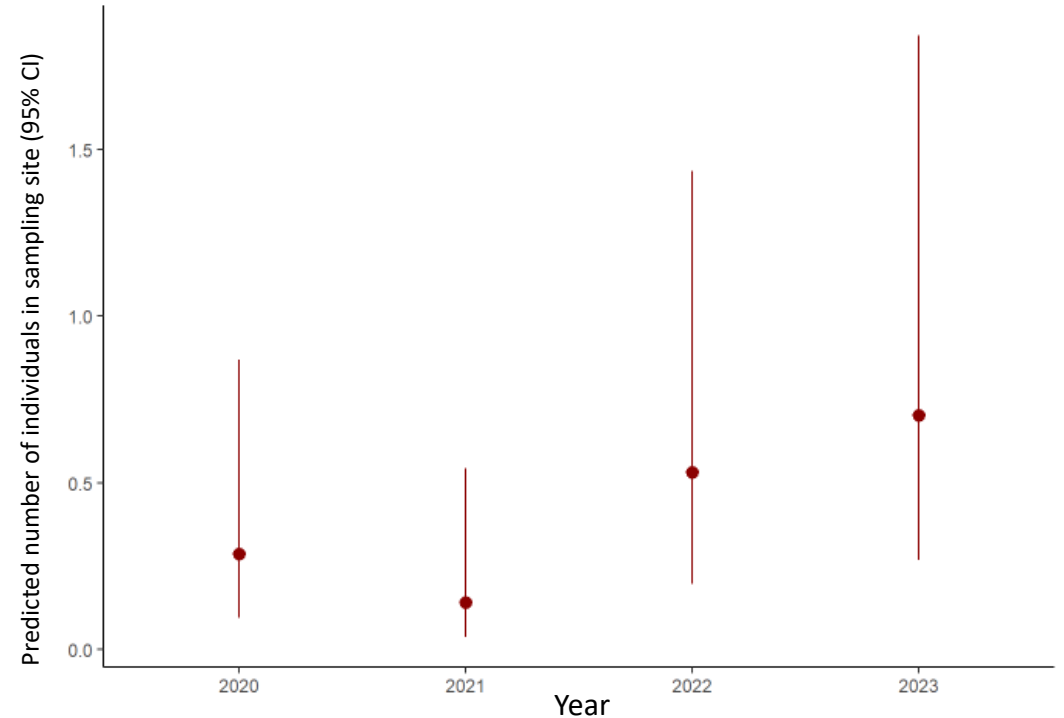
For 0+ age group slight increase of number of specimens was detected

$IRR_{2020\text{vs.}2022}=1.85$ (95% CI 0.60–5.73)

$IRR_{2020\text{vs.}2023}=2.44$ (95% CI 0.79–7.50)

The increase is not statistically significant
($p_{2020\text{vs.}2022}=0.288$, $p_{2020\text{vs.}2023}=0.120$)

1. The spawning success of river lamprey upstream the fish passage has improved, but the increase is smaller than expected;
2. Monitoring should be continued to evaluate further changes in the density of lamprey larvae of all age groups;
3. The results indicate only changes in reproductive success, not overcoming the obstacle, so telemetry studies are also needed.

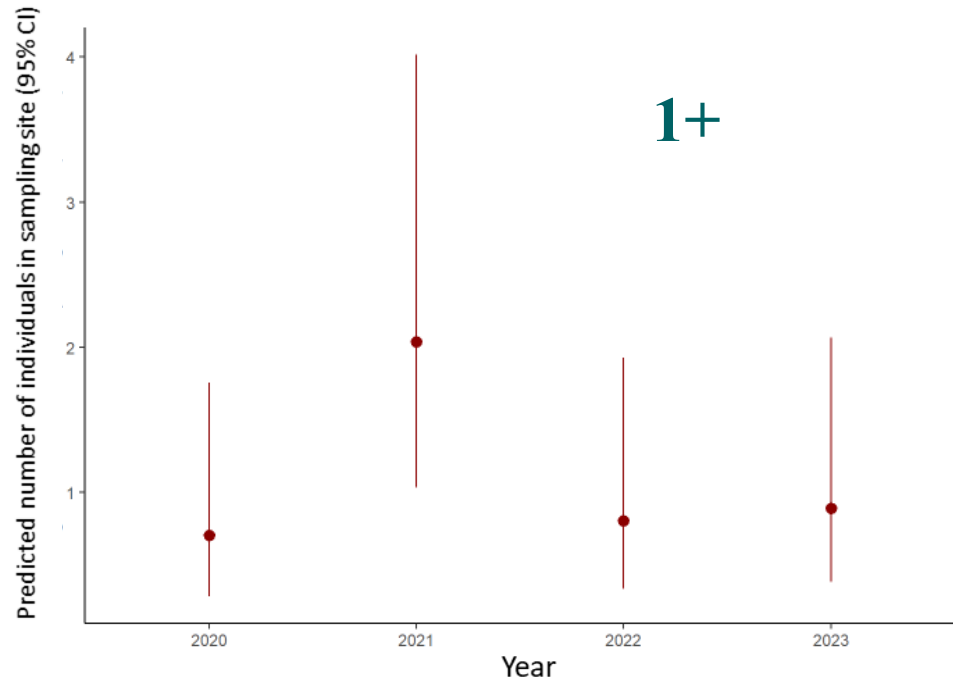
$$IRR_{2020\text{vs.}2022}=1.15 \text{ (95\% CI 0.44–2.99)}$$

$$IRR_{2020\text{vs.}2023}=1.27 \text{ (95\% CI 0.48–3.36)}$$

$$p_{2020\text{vs.}2022}=0.778$$

$$p_{2020\text{vs.}2023}=0.627$$

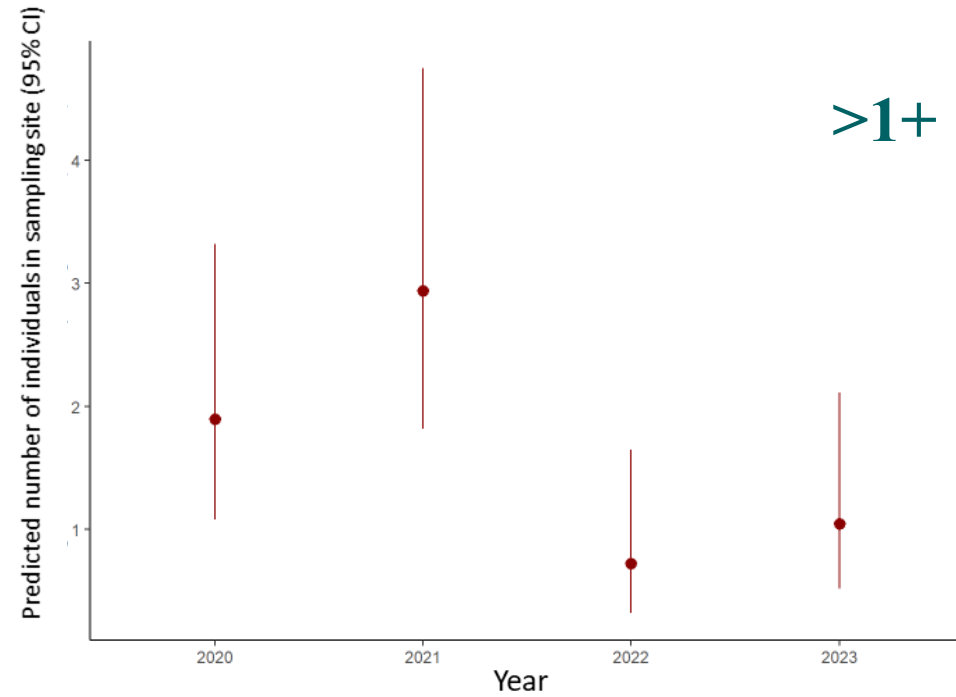
$$IRR_{2020\text{vs.}2022}=0.38 \text{ (95\% CI 0.16–0.93)}$$

$$IRR_{2020\text{vs.}2023}=0.25 \text{ (95\% CI 0.25–1.24)}$$

$$p_{2020\text{vs.}2022}=0.034$$

$$p_{2020\text{vs.}2023}=0.150$$
